# TECHNICAL PROJECT CASE STUDY REPORT

## Exxon

**Project:** #630860

**Asset:** Shell and Tube Heat  
Exchangers x2

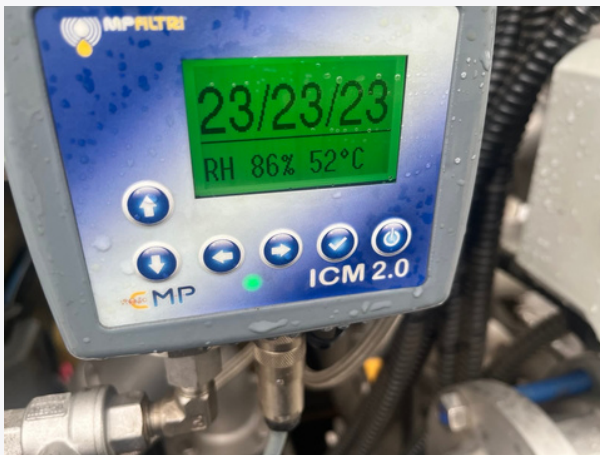
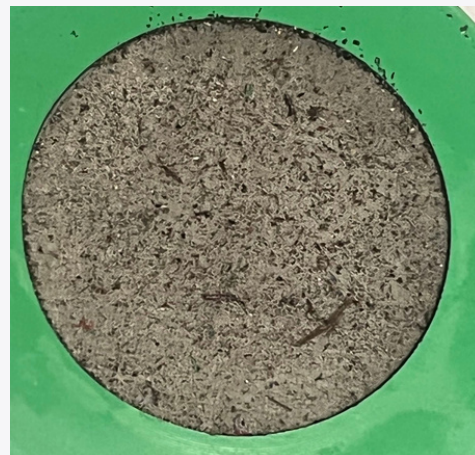
The initial particle count of the FF-2020 fluid passing through exchanger 1102919-101 was recorded after bringing it up to temperature at 15:54. A 3" screen was installed at 13:15 and removed at 17:15 following a 2-hour initial screening. Upon removal, debris remained visible in the spool section, and the screen itself rated a 3 on our scale, indicating the presence of multiple metal fragments.

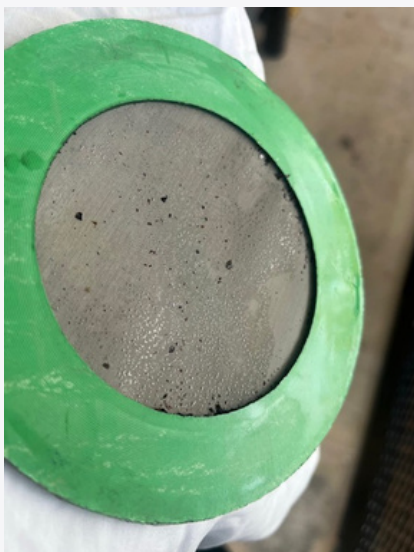
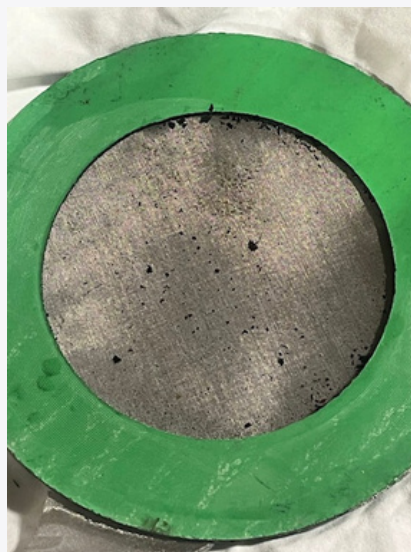
2nd 2-hour screen run from 07:30 – 09:30 on 2/13/25 rated a 2 on our scale with on metallic metal piece confirmed by a magnet

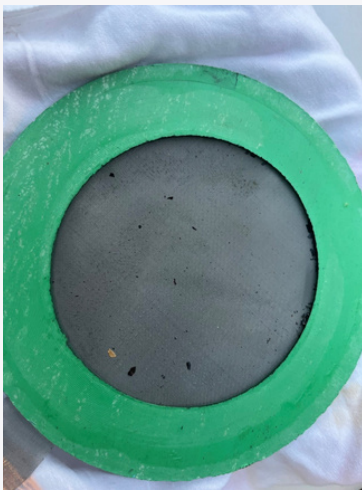
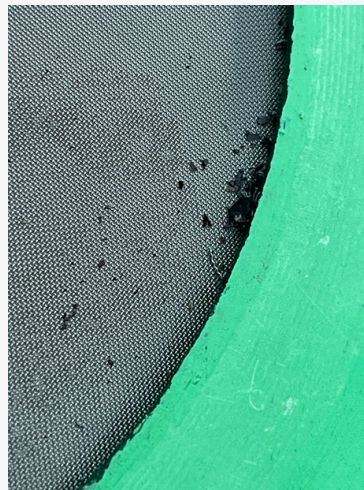
We installed a 3" screen at 16:00 for a 2-hour run to check progress of the flush. This would be close to the 25-hour flush mark. Also, we spoke with Alex on the urgency of needing these exchangers, he said Monday morning is good or whenever they are clean. 16:00 – 18:00 (2/13/25)

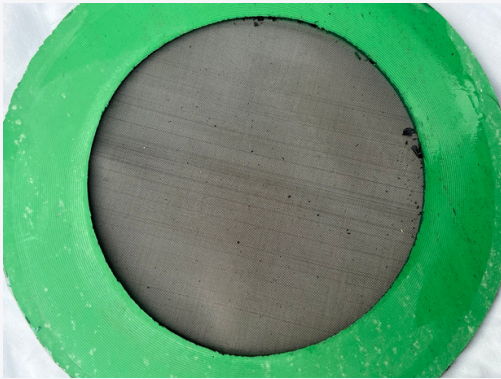
Screen installed at 07:15 for a 2-hour run.  
(07:15 – 09:15) 2/14/25

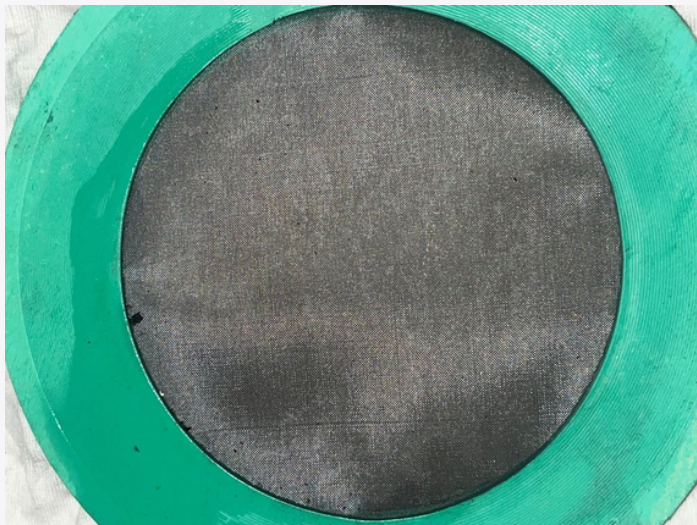
Screen run from 14:00 – 16:00 - Exchanger S/N 11029199-101 was called  
complete at 16:30 on 2/14/25

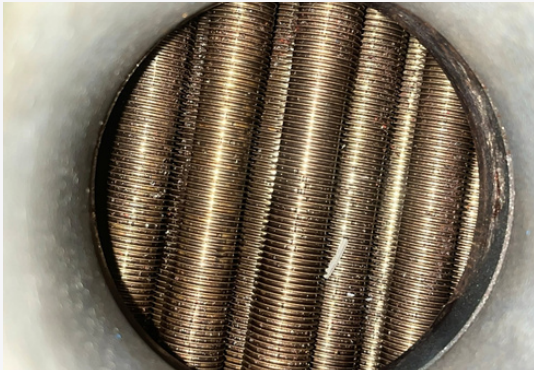
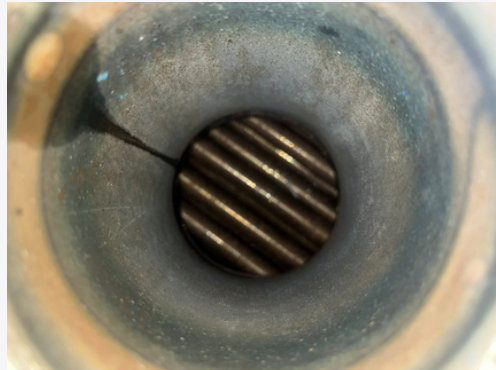
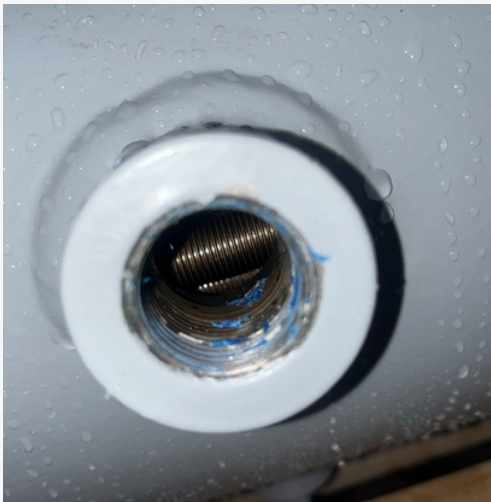
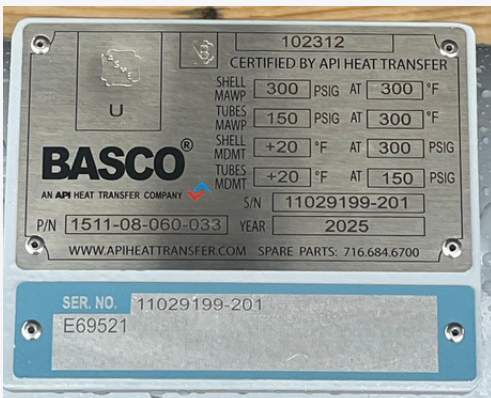
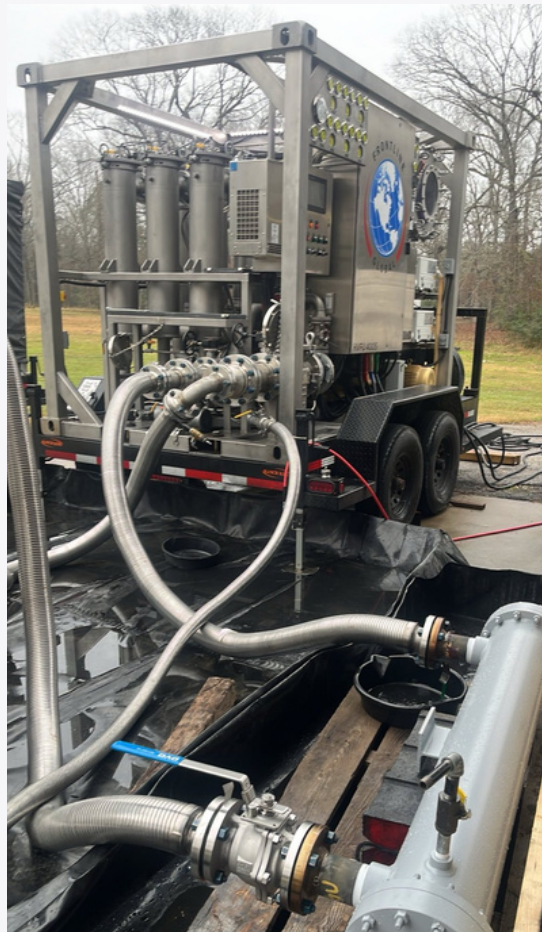
Inspection of exchanger S/N 11029199-201 (small exchanger) during set up

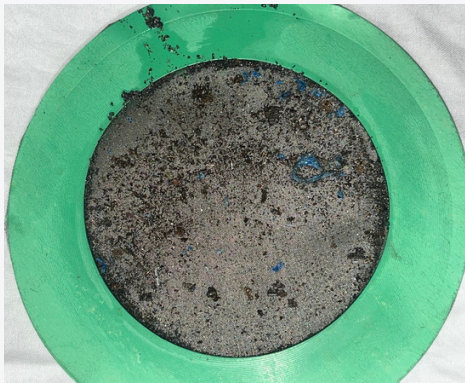
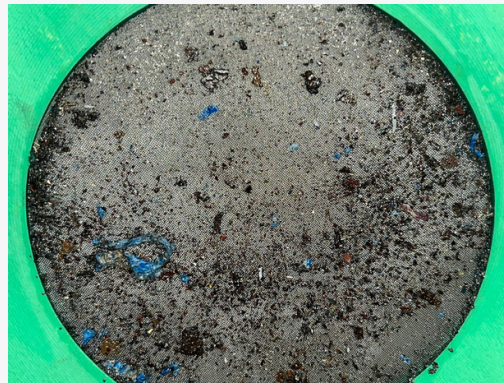
Initial screen run from 17:00 – 18:00 (lots of metal and what looks like brass on the screen as well)

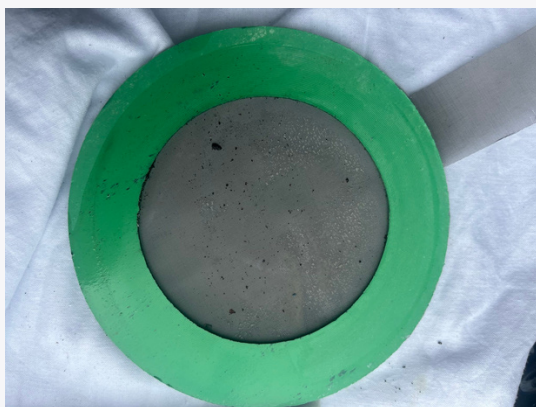
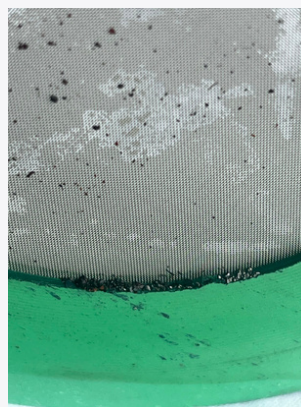
Screen run from 07:15 – 09:15 (2/15/25) lot of metal on screen still some did wash off and you can see a line from what washed off on the screen – 12 hours of flush time

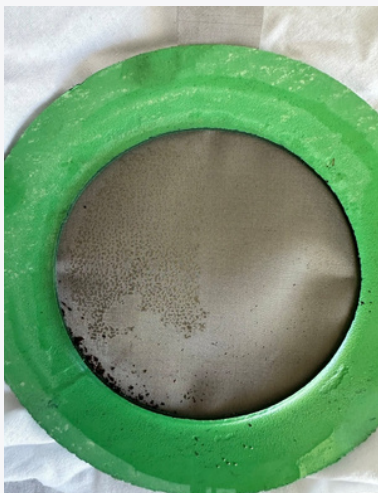
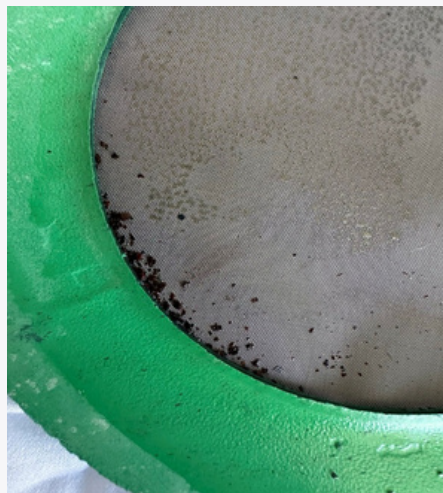
Screen run from 09:30 – 11:30 on 2/16/25 – screen show metal still in system confirmed by use of magnet. We will continue to flush the small exchanger till tomorrow and then run another screen to check.

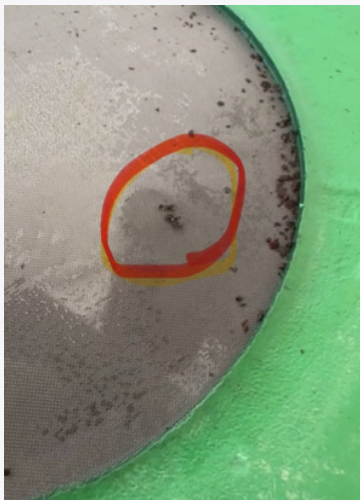
The circled section is the metallic particles that moved around with a magnetic underneath the screen.

Due to the amount of metallic particles on the screen we ran another 24 hours on the small exchanger. This morning's screen was from 08:00 – 10:00. It didn't have any metal present on screen but did have a few hard particles but nothing major.

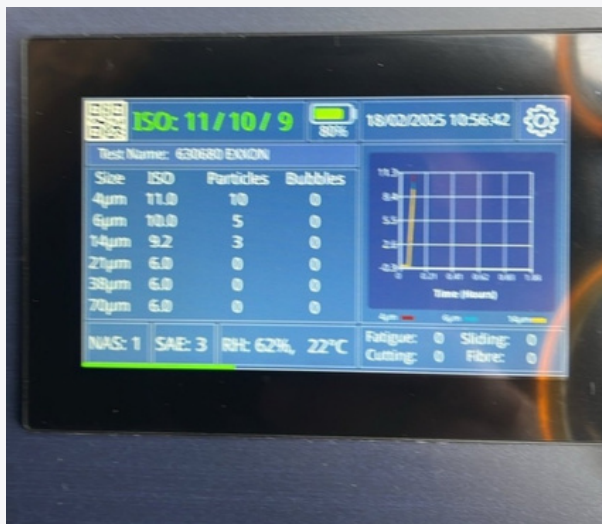
ISO Particle Count 11/10/09

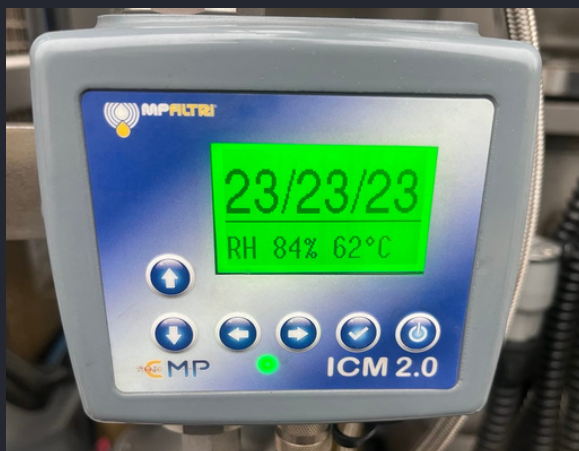
Before Project: ISO (23/23/23)

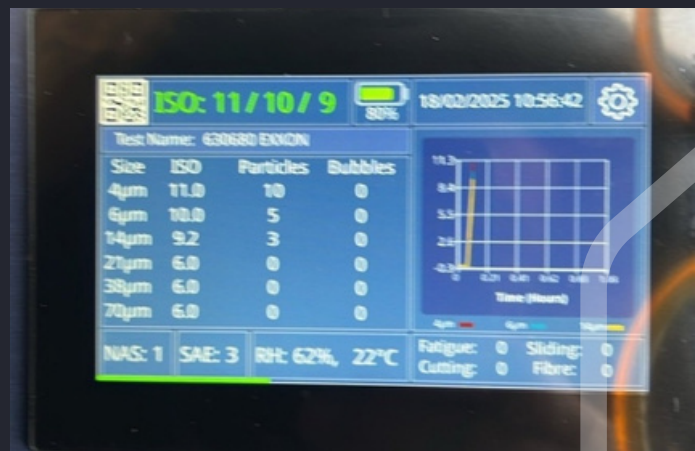
After Project: ISO (11/10/9)
