**maxcomp**

Pipe and Pressure Equipment, Composite Repair Systems

# Composite wrap repair Success Cases

# Maximizing your asset's efficiency with the best quality composite repair systems.

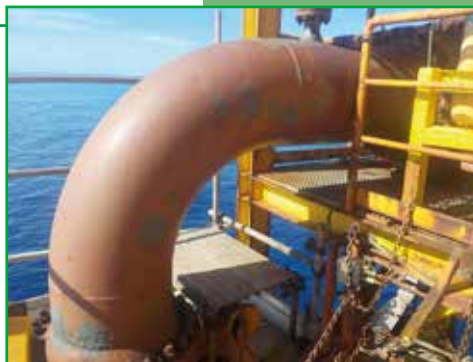
Lines worn out by external corrosion causing loss of thickness, which can lead to rupture and total system failure.

Due to the high gas pressure and contact with ocean air, the platform lines suffered external wear due to corrosion, reducing the thickness in one of the 90° curves, where the temperature of the liquids transported can exceed 70°.

Initial appearance of the line

1. Depressurization and draining of the line for repair.
2. Application of abrasive blasting to clean and prepare the surface, creating the roughness necessary to fix the coating.
3. Choice of **MaxComp 9182** coating due to the epoxy matrix reinforced with bidirectional fiberglass fabric with resistance up to 130°, suitable for pressurized equipment and complex geometries.

Application of 330 mm of coating in 300 mm of line.

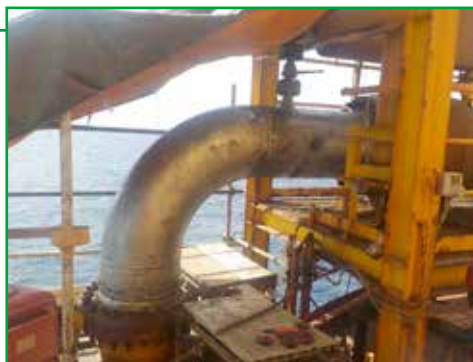
90° bend with abrasive blasting

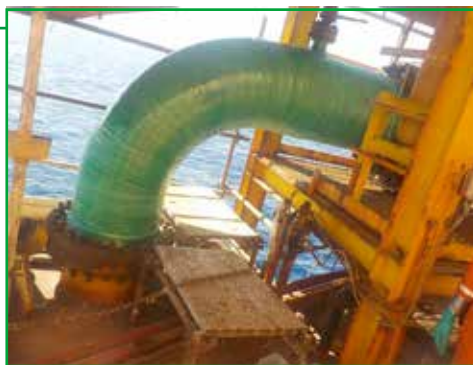
330 mm of Maxcomp applied

For 3 months, the lines were inspected by the maintenance team, with no reports of wear and pressure changes on the system's internal walls.

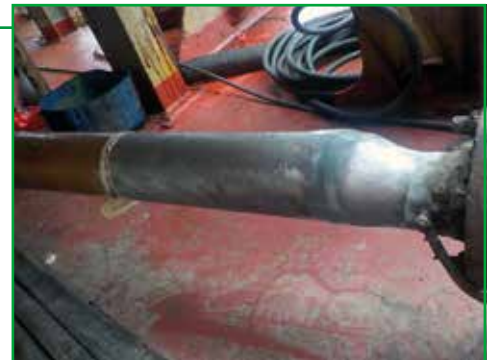
abrasive jet blasting

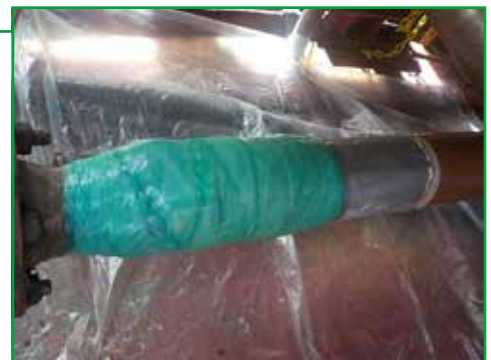
Maxcomp applied

The repairs were carried out in a few hours, with the leak being completely sealed using fiberglass lining.

The gas system returned to operation in less than 24 hours at full capacity and without new leaks.

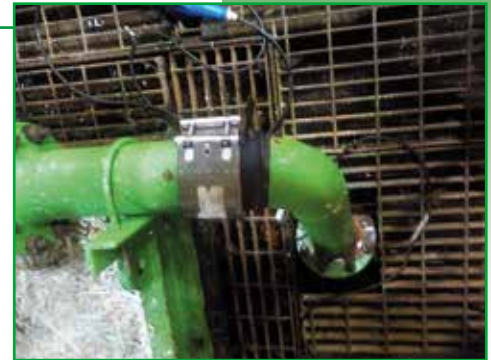
Lines worn out due to internal corrosion with a damaged area of 10 mm, with a large leak of water used for cooling in the engine room.

Due to the continuous flow of seawater in the cooling process, in addition to the corrosive damage caused by the sea air, with the oceanic air, the piping near the 90° bend suffers severe damage and with the high water pressure, a high external leak flow.

*Initial appearance of the line*

1. Depressurization and draining of the line for repair.
2. Application of abrasive blasting to clean and prepare the surface, creating the roughness necessary to fix the coating.
3. Application of **MaxComp 9182** indicated for pressurized equipment and complex geometries, in addition to resistance to high temperatures and pressures.

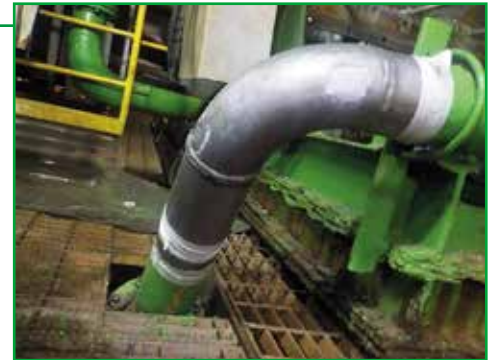
*90° bend with abrasive blasting*

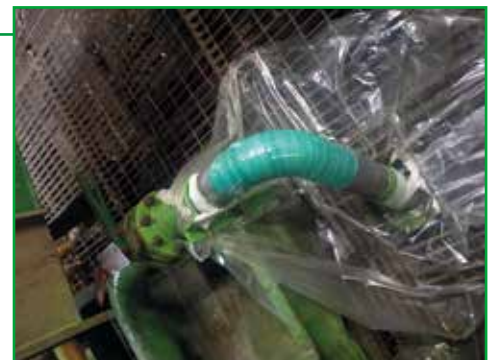
*Maxcomp applied*

The system was turned back on a few hours after completing the repair and reinforcement with MaxComp 9182, when the machine room returned to full functionality.

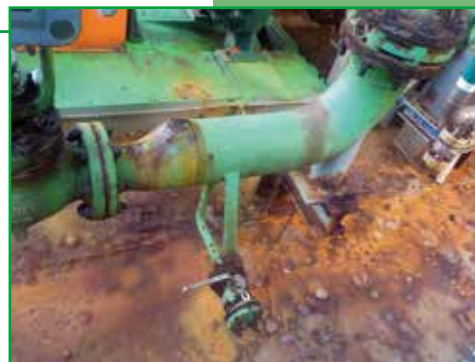
High degree of corrosion and erosion external due to sea air, causing serious damage to a pipe reduction area. Due to the high temperatures, the team had to use flame-retardant equipment.

The presence of microorganisms that induce corrosion and variations in temperature and pressure contribute to the deterioration of the metal surfaces of pipes.

The design pressure was 15 bar, with a temperature above 60°.

Initial appearance of the line

1. Depressurization and draining of the line for repair.
2. Application of abrasive blasting to clean and prepare the surface, creating the roughness necessary to fix the coating, in addition to leveling areas with a high degree of corrosion.
3. Application of MaxComp 9182 was recommended due to the high temperature and water pressure indices in the piping.

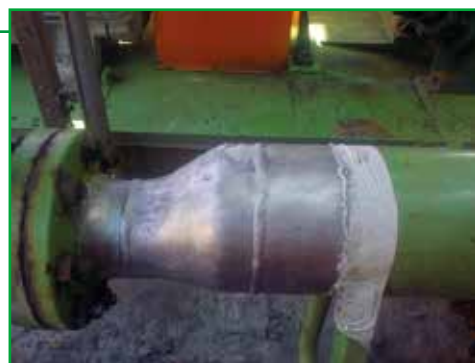
Reduction area with abrasive blasting

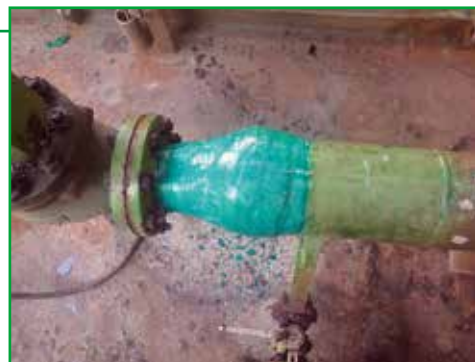
Maxcomp applied

The repair of the corroded surface occurred as planned and the system was restarted within a few hours to its full operating capacity, avoiding further damage to the platform's operation.

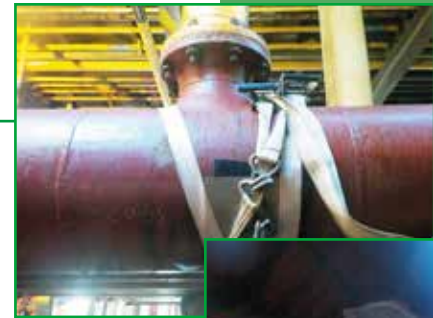
The leak was located in a section of the line where the flow could not be contained for the repair. The leak was located below the drain, approximately 150mm thick by 650mm in diameter. Due to the high temperatures, the team had to use flame-retardant equipment.

The presence of microorganisms that induce corrosion and variations in temperature and pressure contributed to the deterioration of the drain surface and the failure to use adequate repairs made this leak more complex.

*temporary structure reinforcement in the Tee...*

*...and the leak*

1. Application of abrasive blasting to clean and prepare the surface, creating the roughness necessary to fix the coating, with post-application of the Maxmetal metallic coating for first sealing.
2. Application of MaxComp 9182 was recommended due to the high temperature and water pressure indices in the piping.

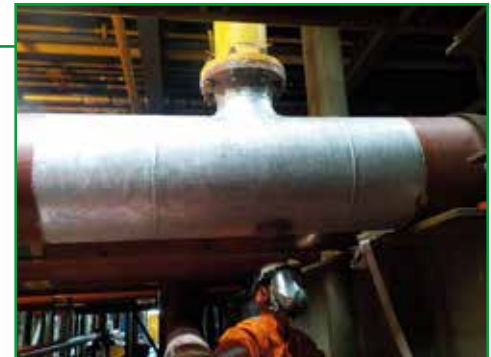
*Reduction area with abrasive blasting*

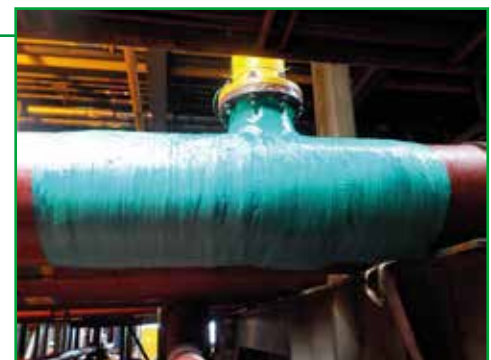
*Maxcomp applied*

The leak repair took place very carefully and within the initial project expectations, with the system returning to full functionality within a few hours after the work was completed.

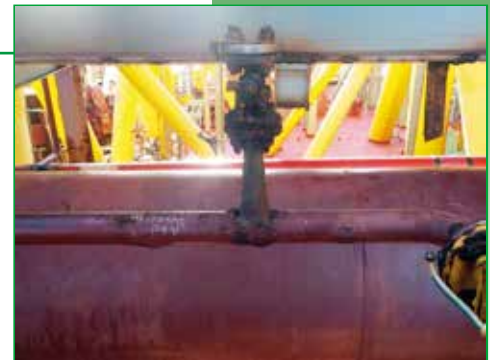
The valve structure was completely covered by corrosion due to the action of wind and sea air, causing loss of thickness and a high possibility of leakage

The presence of corrosion-inducing microorganisms due to sea air and variations in temperature and pressure contributed to the deterioration of the register surface, leading to the need for more aggressive preventive maintenance.

Initial appearance of the line

1. Application of abrasive blasting surface preparation - cleaning, roughening and leveling, for greater effectiveness in fixing the elastic coating.
2. The application of MaxComp 9182 was recommended due to the high temperature and pressure of the water in the pipe.

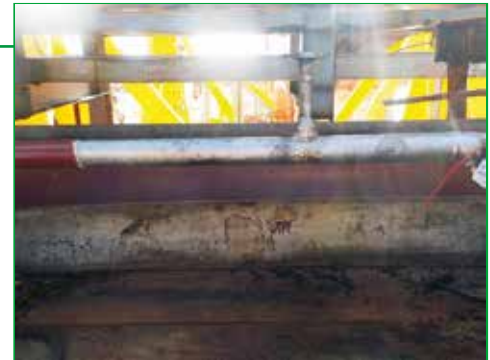
Abrasive jet blasting

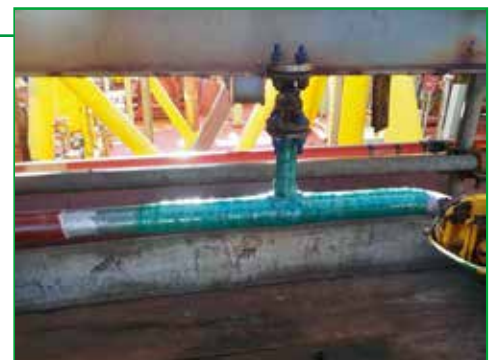
Maxcomp applied

Preventative maintenance through the application of Maxcomp coating achieved the expected results, eliminating all possibilities of leaks in the T region, with the system being monitored since then, in order to avoid leaks.

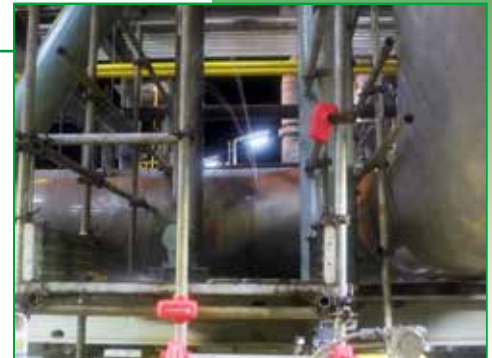
Two cracks after a 90° bend in the main pipe responsible for transporting seawater to cool pumps, causing a leak. The entire service was carried out in an area that was difficult to access and required depressurization of the system for the repair.

The presence of corrosion-inducing microorganisms due to sea air and variations in temperature and pressure within the pipe contributed to a decrease in the thickness of the main pipe.

Initial appearance of the line with the high pressure leak

1. Application of abrasive blasting to clean and create the roughness necessary to fix the coating.
2. The application of MaxComp 9182 was recommended due to the high temperature and pressure of the water in the piping.

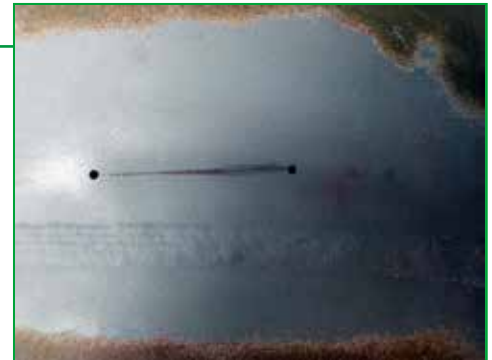
Abrasive blasting site showing leaks

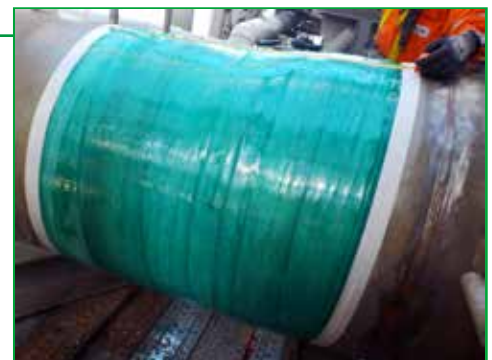
Maxcomp applied

100mm of Maxcomp was used to completely seal and structurally reinforce the region of the line that was already showing a decrease in thickness. The application of the coating exceeded expectations, eliminating any possibility of new leaks at the site.

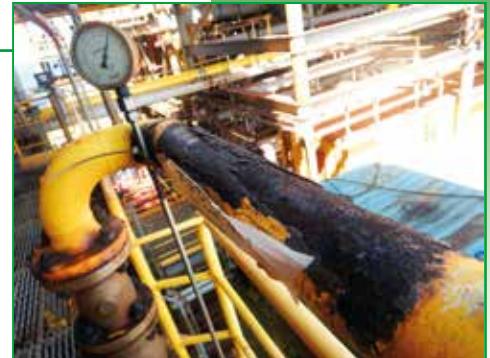
The high system pressure and high internal liquid temperature caused severe damage to the system tubes, requiring extensive surface preparation.

The high pressure of the diesel oil transport system, as well as the high temperature of the liquid inside the pipe, in addition to the sea air caused by the location very close to the ocean, caused severe corrosive damage.

Initial appearance of the line with severe corrosion

1. Application of abrasive blasting to clean and surface leveling for adequate preparation when receiving the coating.
2. The application of MaxComp 9182 was recommended due to the high system pressures and high diesel oil temperatures.

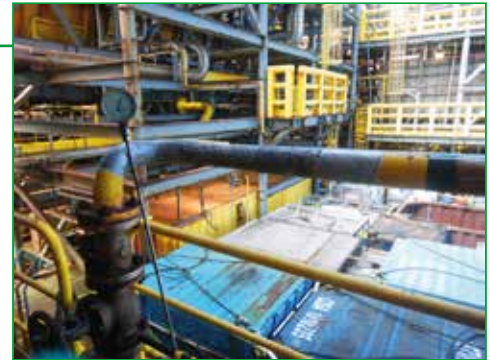
Abrasive blasting leveling the surface

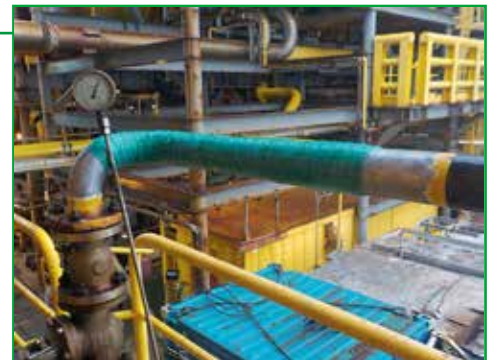
Maxcomp applied

120mm of Maxcomp was used to eliminate any possibility of leakage, creating a new surface layer on the pipe, from the straight line to the coating of the 90° curve.

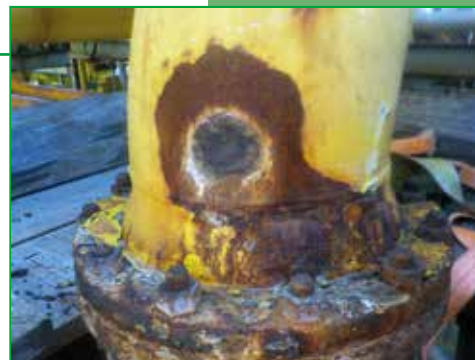
The high pressures and temperatures of the line to be repaired due to the type of liquid transported, requiring depressurization of the system, required careful surface preparation work to better fix the coating.

The high pressure of the recovered oil transport system and the high temperatures of the liquids inside the pipe, in addition to the sea air, caused severe internal and external corrosive damage to the system.

Initial appearance of the line

1. Application of abrasive blasting to clean and roughen the surface for adequate preparation upon receipt of the coating.
2. The application of MaxComp 9182 was recommended due to the high system pressures and high temperatures of the liquid transported in the lines.

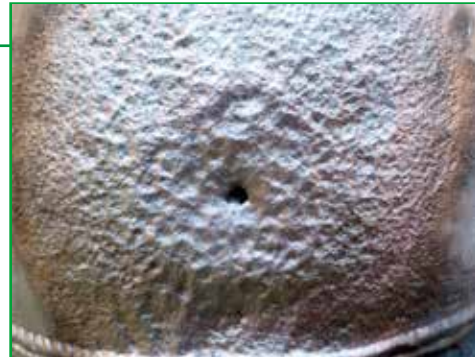
Abrasive blasting

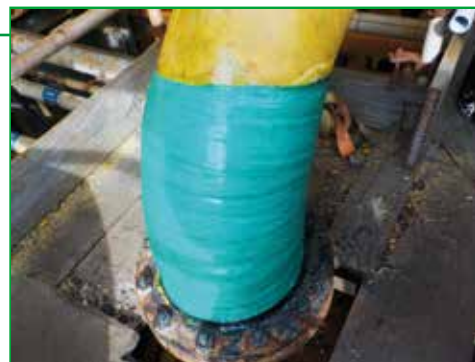
Maxcomp applied

The choice of Maxcomp to eliminate any possibility of leakage created a new layer of coating on the pipe, with the system returning to full operation hours later.

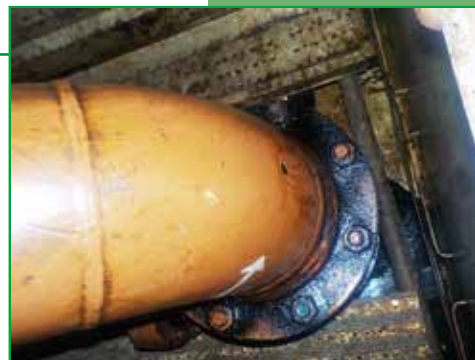
Temperatures above 70° and pressures above 16 bar made it necessary to depressurize the entire section of the system, requiring an extensive surface preparation area, in addition to reinforcing the coating at the junction.

The high pressure of the system and the temperature of the process liquid, in addition to the sea air, caused a severe leak near the junction of the system section.

Initial appearance of the line the hole near the junction

1. Application of abrasive blasting to clean the fluids from the leaked liquid over a larger area, in addition to creating greater surface roughness.
2. The application of MaxComp 9182 was recommended due to the high system pressures and high liquid temperatures. With reinforcement in the amount of coating closest to the junction region.

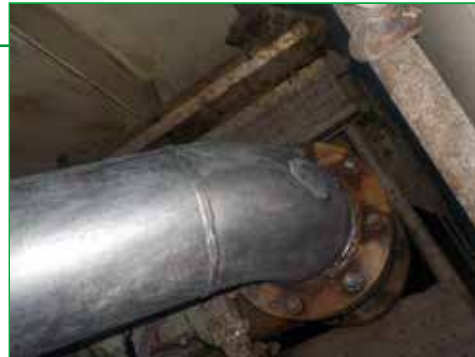
Abrasive blasting cleaning the surface

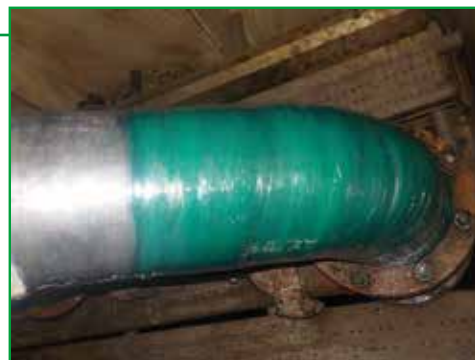
Maxcomp applied

After a cautious surface preparation process, the application of Maxcomp resolved the leak, with the system returning to normal operation within a few hours.
