# JOHN WESLEY DOBBS - AS-BUILT DOCUMENTATION

The 684 John Wesley Dobbs project centers on the precise architectural documentation of an existing, unpermitted accessory structure located behind a mixed-use commercial building in the BeltLine Overlay district of Atlanta. Constructed by a previous tenant without City approvals, the enclosure—paired with an attached deck and lightweight shed roof—triggered a stop-work order, requiring a retroactive building permit supported by an accurate, professionally prepared as-built record.

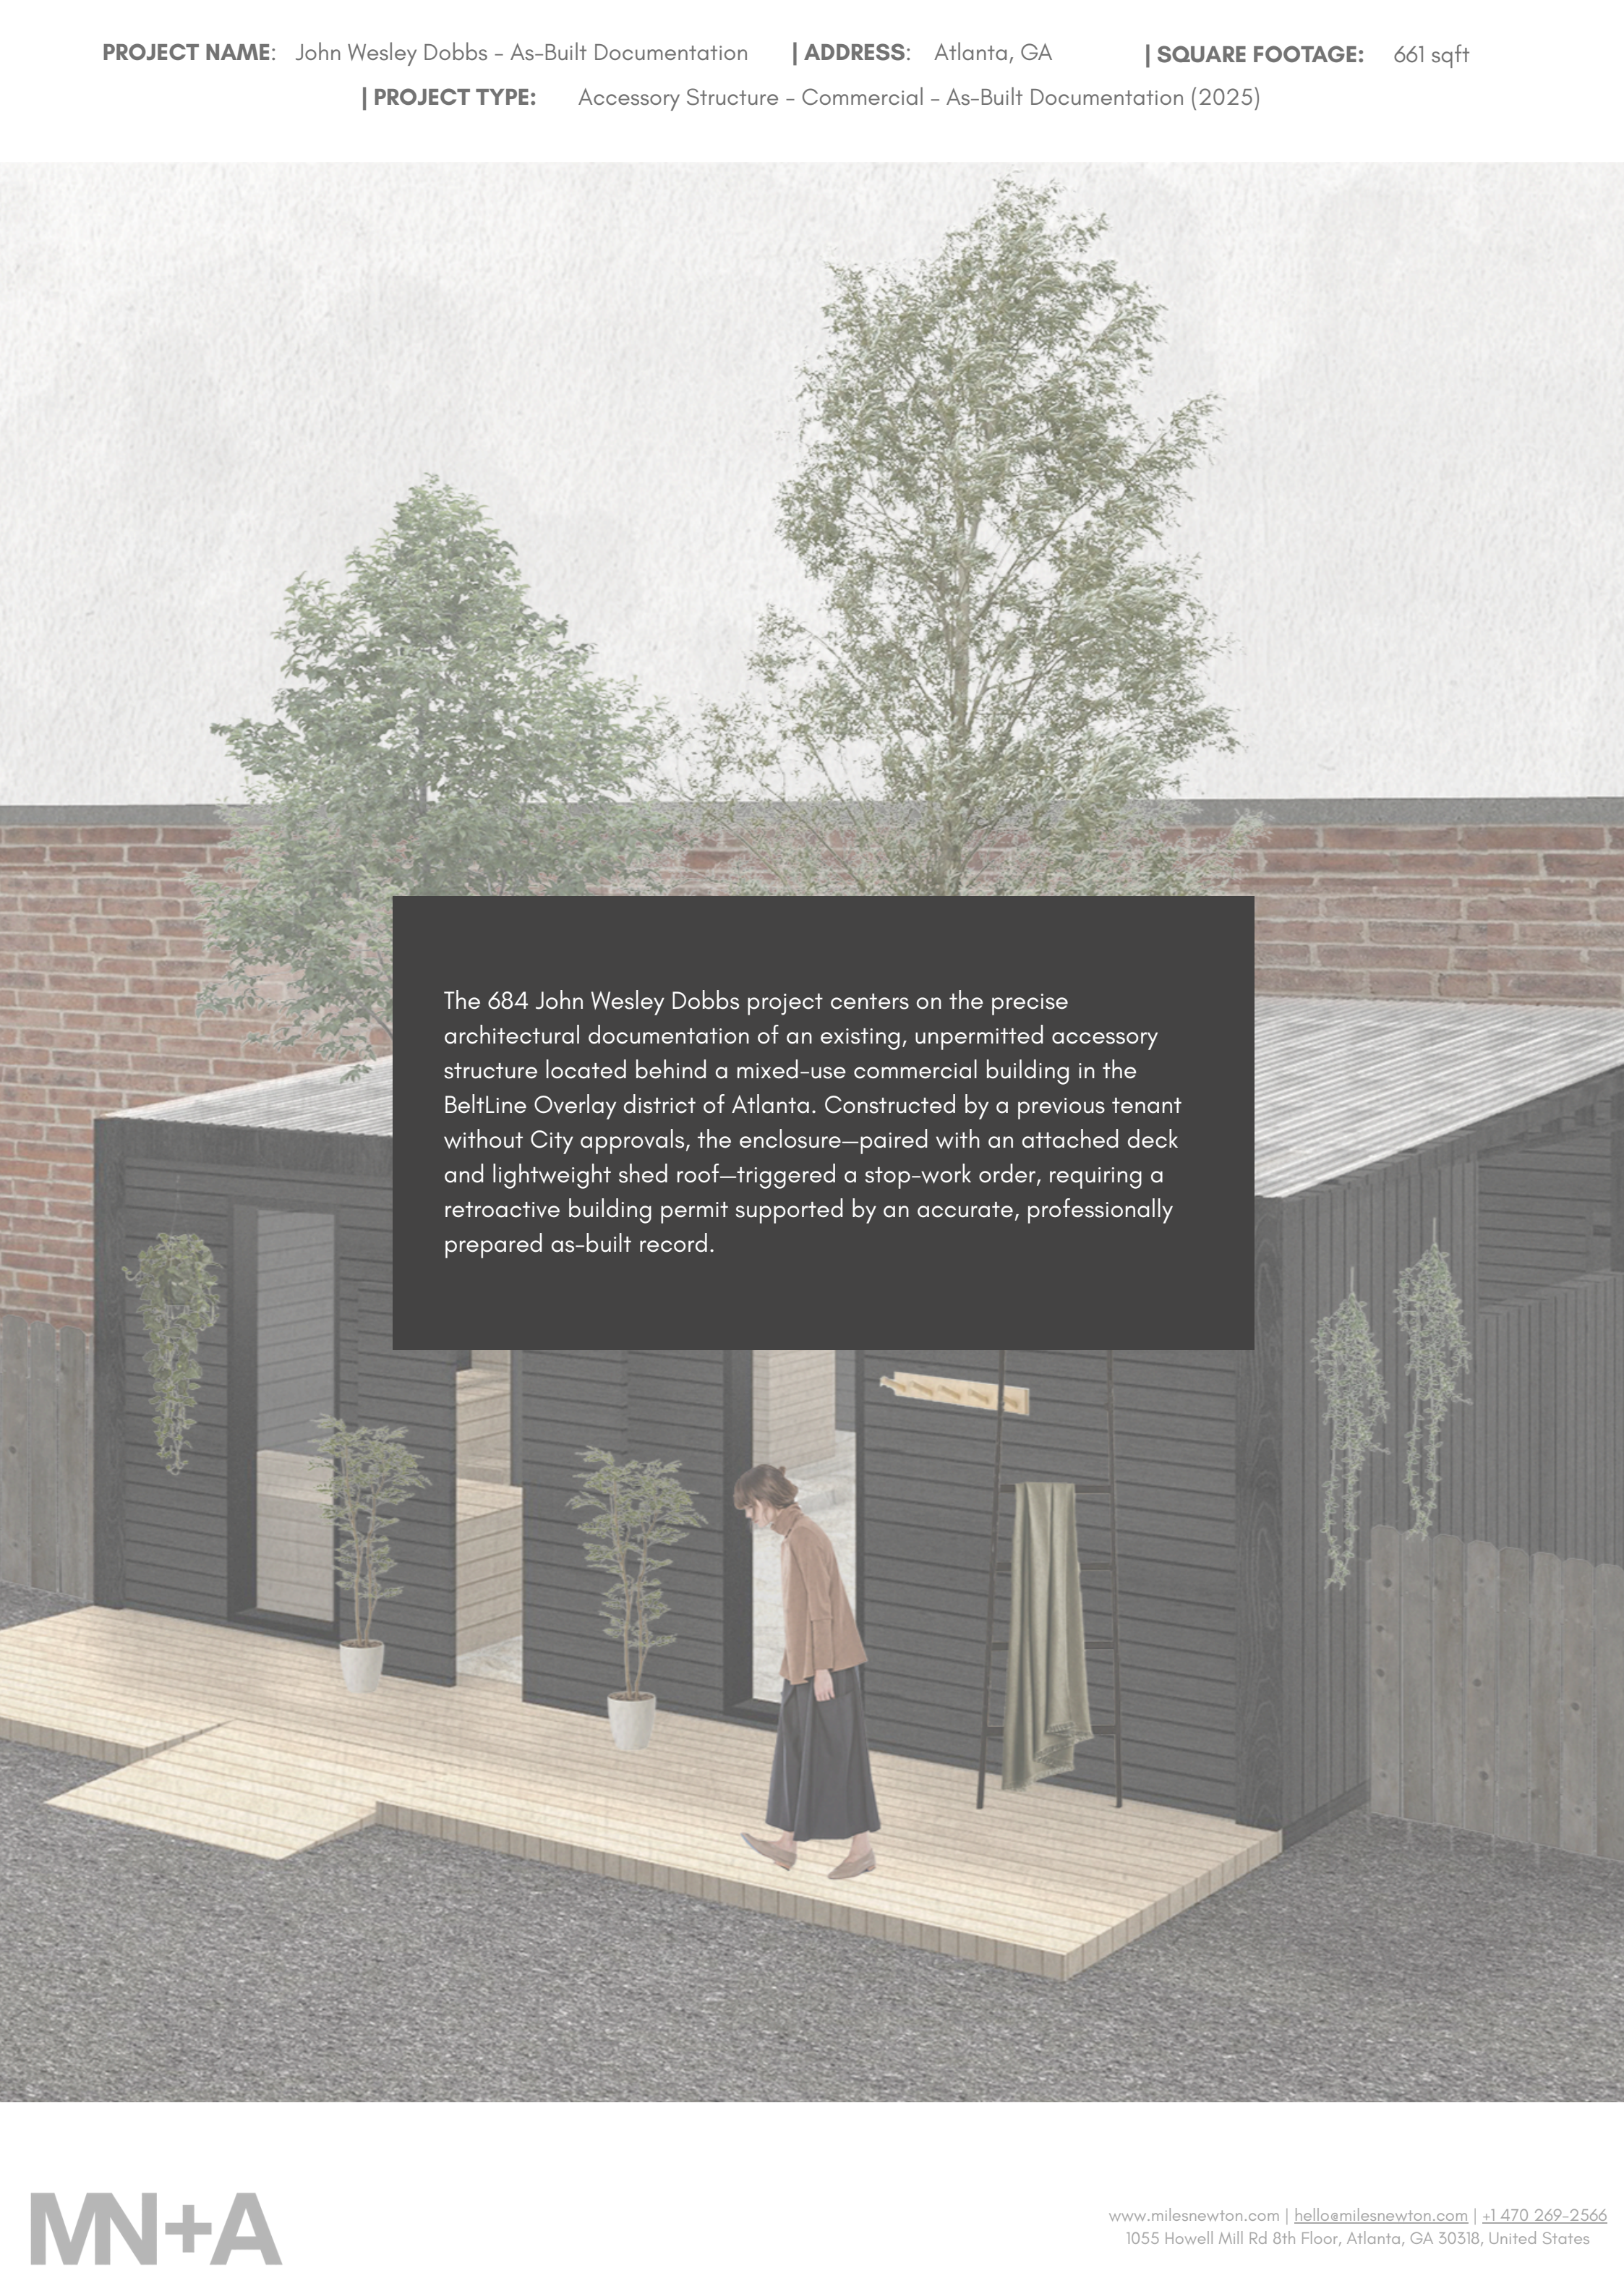
An architectural rendering of a modern, dark-colored accessory structure. The structure features dark horizontal siding and a corrugated metal roof. A woman in a brown jacket and dark skirt is walking on a light-colored wooden deck in front of the structure. The deck has several potted plants and a hanging plant. The structure is situated behind a brick wall, and there are trees in the background.

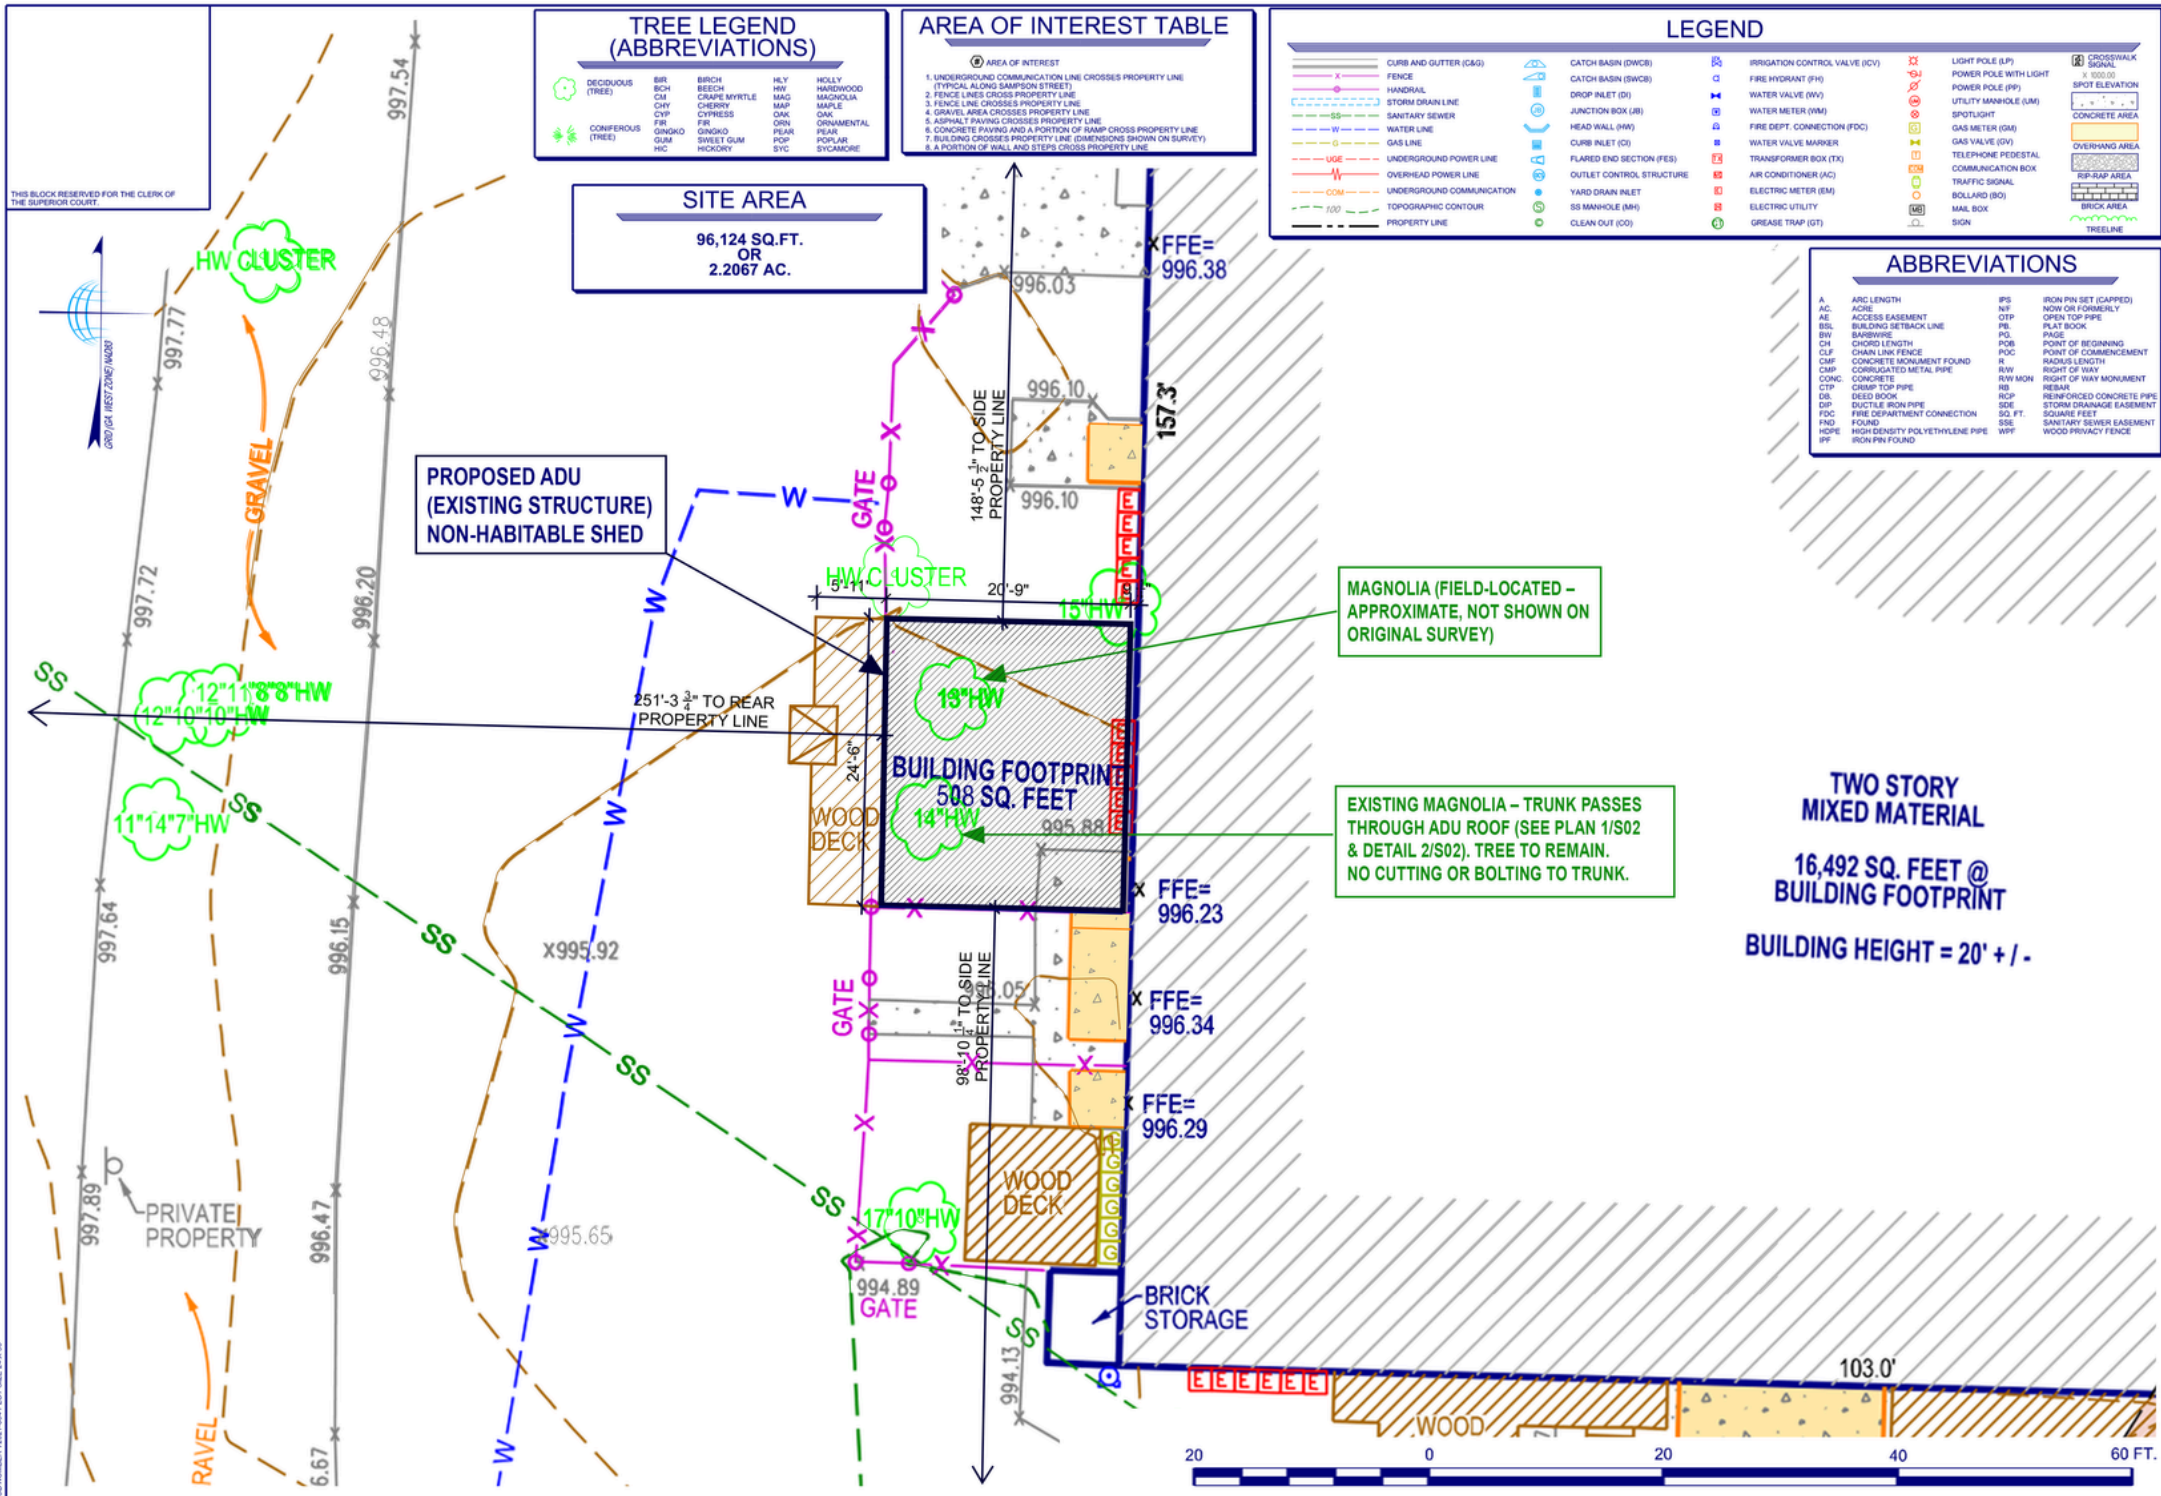
ENLARGED SITE PLAN - ADU & MAGNOLIA TREES  
 Scale Bar

- EXISTING MAGNOLIA TREES ADJACENT TO ADU TO REMAIN.
- ADU ROOF IS CONSTRUCTED AROUND EXISTING TREE TRUNKS WITHOUT CUTTING, BOLTING, OR MECHANICALLY FASTENING TO THE TREE.
- NO ROOT EXCAVATION, GRADE CHANGE, OR CONCRETE WORK IS PROPOSED WITHIN THE CRITICAL ROOT ZONE OF THE MAGNOLIA TREES.
- SECOND MAGNOLIA TREE LOCATION SHOWN BASED ON FIELD MEASUREMENT (NOT ON ORIGINAL SURVEY).

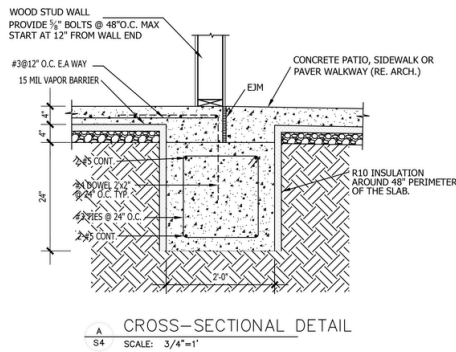
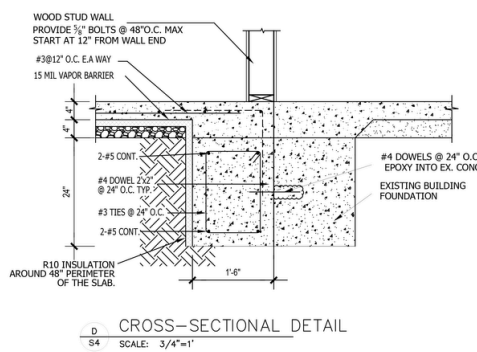
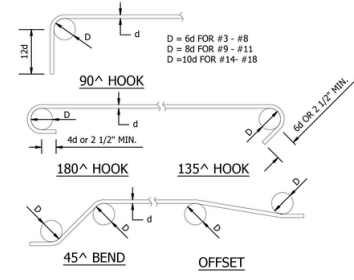
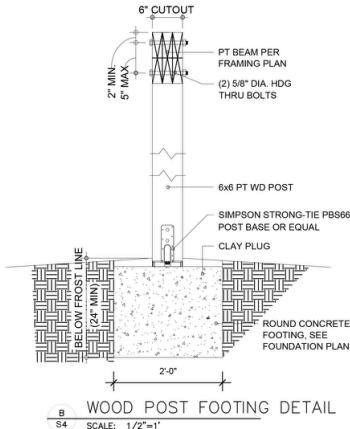
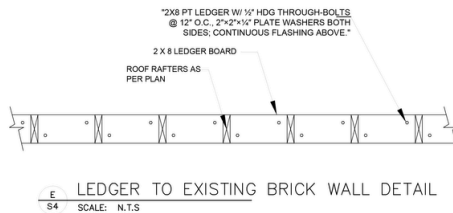
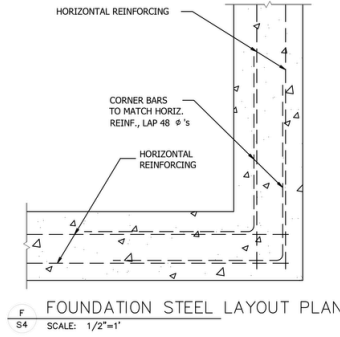
# STRUCTURAL DETAILS

**AS-BUILT STRUCTURAL NOTE:** DETAILS REFLECT OBSERVED EXISTING CONSTRUCTION. WHERE CONDITIONS DIFFER IN THE FIELD, THE AS-BUILT WORK REMAINS STRUCTURALLY SOUND PER OBSERVATION. DEVIATIONS NOT AFFECTING SAFETY NEED NOT BE REVISED. CORRECTIVE WORK, IF REQUIRED, WILL BE PERMITTED SEPARATELY.
