Property Inspection Report

Example Report Seattle, WA 98112

Date of Inspection
March 26th, 2024
11:00 AM

Guardian Home Inspection Services,
LLC
(206) 588-6317

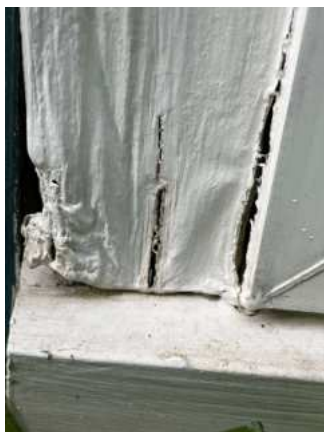
Trim / Fascia
Section 1.2
Page 13

Repair or Replace - Immediately:
Basement south facing window shows noticeable signs of rot. Trim should be replaced to prevent any further damage to the structure.

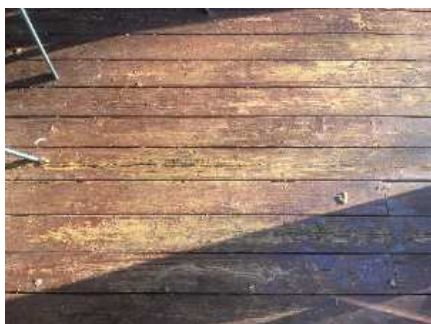
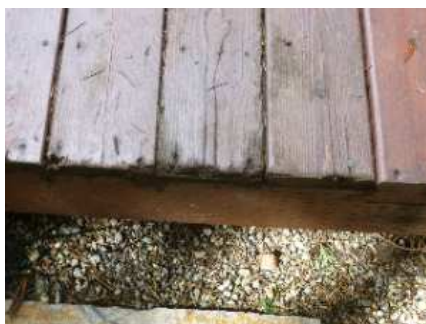
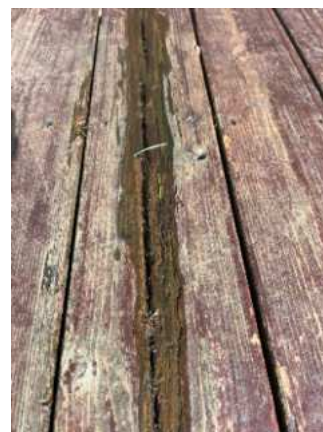
Decks
Section 1.4
Page 14

Decking shows signs of water damage and sun exposure. Recommend replacing damaged areas to prevent future structural damage and add to the longevity of the deck.

Upgrade - Improve for Longevity:
There are large areas of the deck in need of a protective stain to protect wood from the elements.

Monitor deck for further rot and damage.

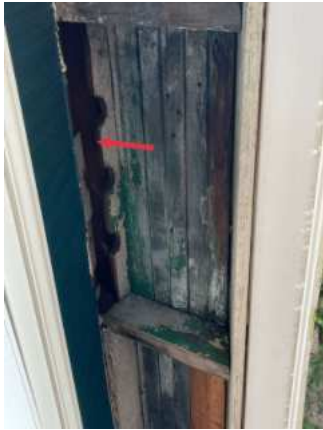
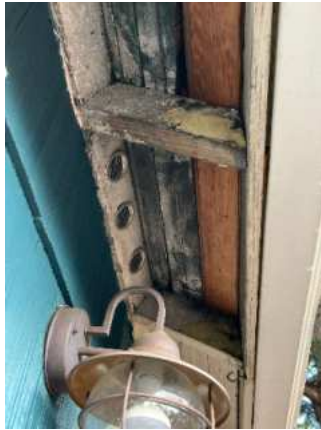
Soffits
Section 1.7
Page 16

Mold growth on soffits is generally black or dark grey and has a splotchy, semi-circular, and irregular appearance. Gone untreated, mold growth on exterior components can lead to accelerated deterioration over time. In the worst-case scenarios, it can deteriorate the roof framing and sheathing, leading to costly repairs. Additionally, the mold will likely continue to grow, which is aesthetically unpleasing.

Mold and early stages of rot present on soffit.

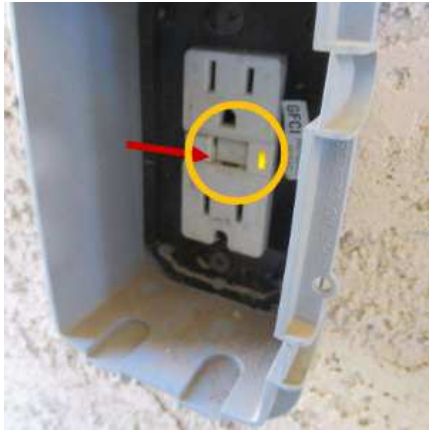
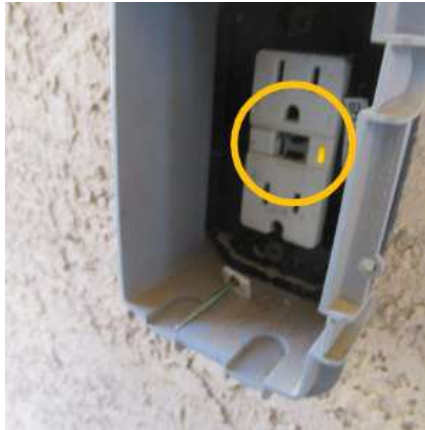
The test button on the GFCI is broken and should be repaired or replaced immediately.

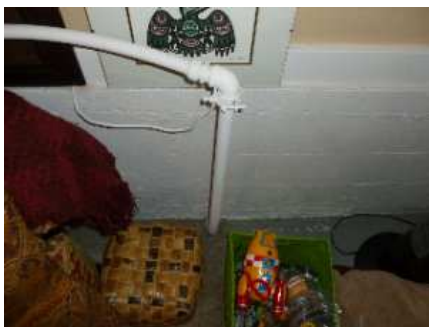
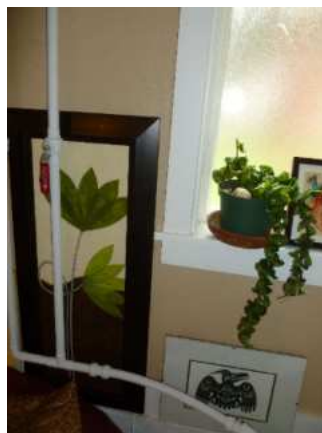
Over time, the galvanized steel pipes begin to rust or corrode from the inside out, resulting in reduced water pressure and restricted water flow. This presents an increased risk of leaks or ruptures occurring in the pipes and the potential for flood damage.

Polybutylene pipes and fittings are prone to breaking and leaking, and they have a lifespan 10 to 15 years. Suggest having these pipes reviewed by a plumbing professional.

Galvanized steel water pipes should be periodically monitored for leaks.

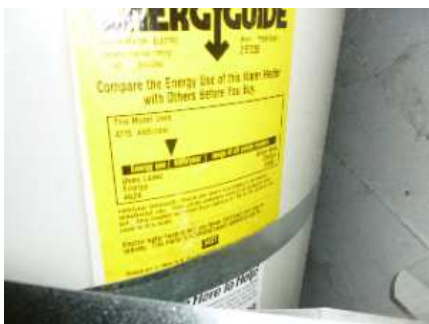
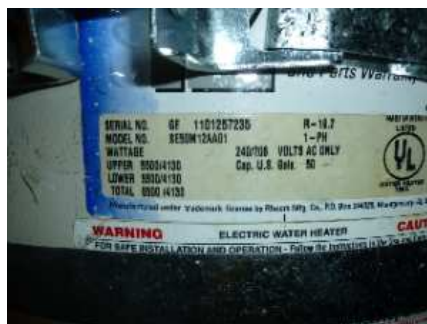
Water Heater Approximate Age
Section 5.4
Page 33

Water heater is past life expectancy.

The tank to your water heater should be flushed on an annual basis. Doing so drains the sediment from the tank, which is then able to work more efficiently. With a yearly tank flush, a water heater is likelier to last for its full life expectancy of roughly ten years.

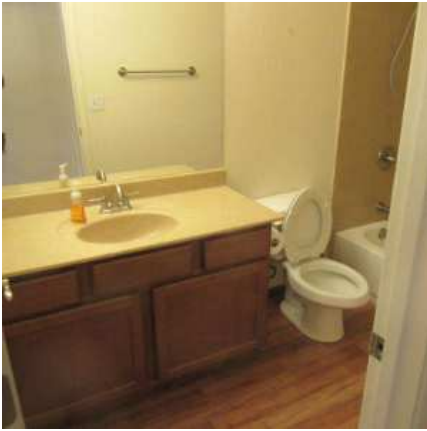
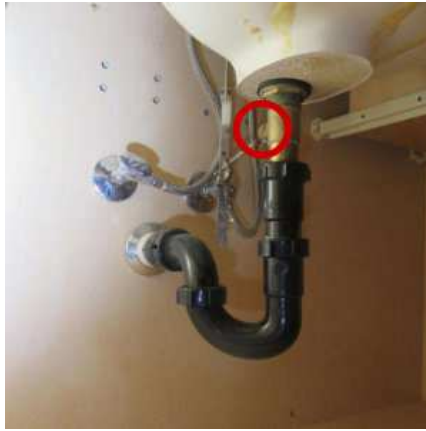
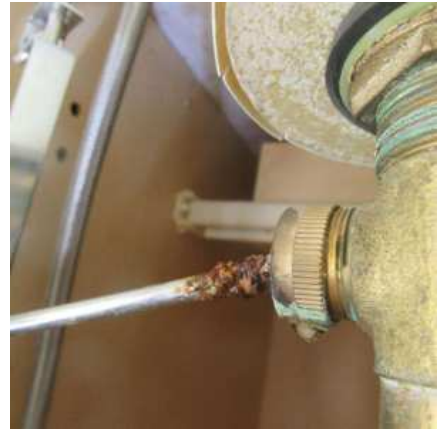
Bathroom Sinks
Section 5.10
Page 36

Repair or Replace - Immediately:
A leak is present at the stopper rod/drain connection. The mechanism can be dismantled to check seals for wear or cracks.

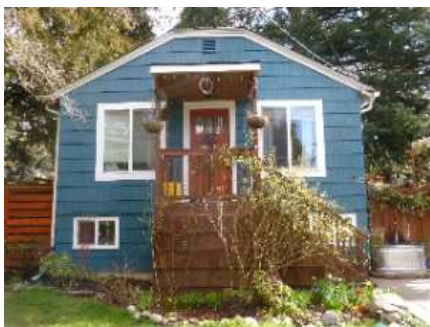
Image 1.1.1

1.1 Exterior Wall Coverings Exterior	Description	<ul style="list-style-type: none"> • Wood
	Condition	<ul style="list-style-type: none"> • Repainted

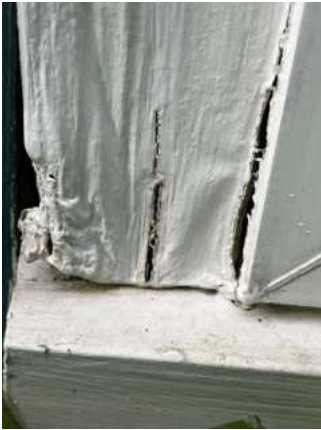
Repair or Replace - Immediately: Basement south facing window shows noticeable signs of rot. Trim should be replaced to prevent any further damage to the structure.

Image 1.2.1 Rot present on basement window trim along south facing wall.

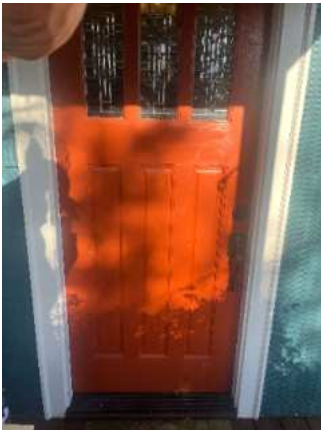
Image 1.3.1

Front door lock sticks but is operational. Monitor and consider having reviewed by professional to determine cause.

Monitor Front door lock sticking but operational. Have reviewed by a professional to determine cause.

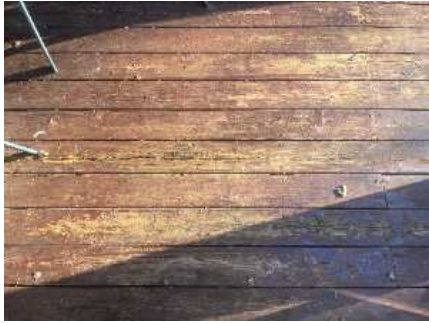
Image 1.4.1

Decking shows signs of water damage and sun exposure. Recommend replacing damaged areas to prevent future structural damage and add to the longevity of the deck.

Upgrade - Improve for Longevity: There are large areas of the deck in need of a protective stain to protect wood from the elements.

Monitor deck for further rot and damage.

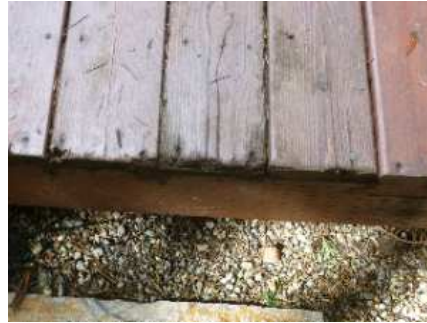
Image 1.4.2

Condition • Rotted
• Loose
• Damaged

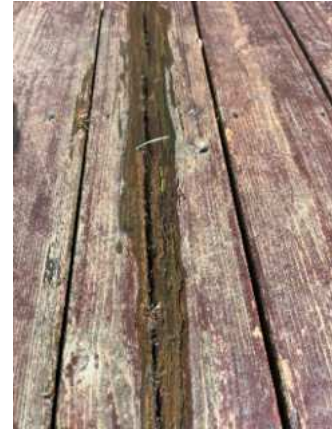
Image 1.4.3 Rot from water penetration. Deck board should be replaced.

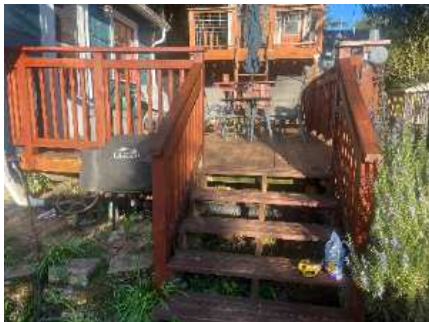
Image 1.5.1

Upgrade - Increase Performance: Handrails are not graspable. Safety concern.

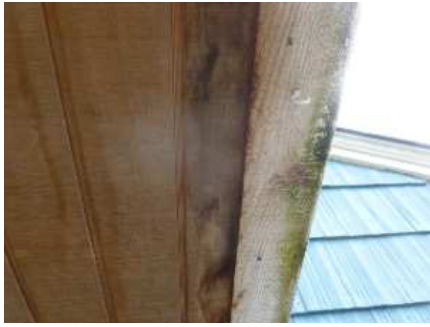
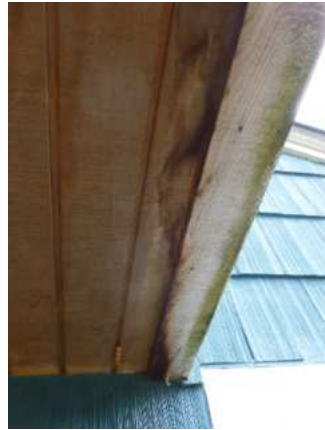
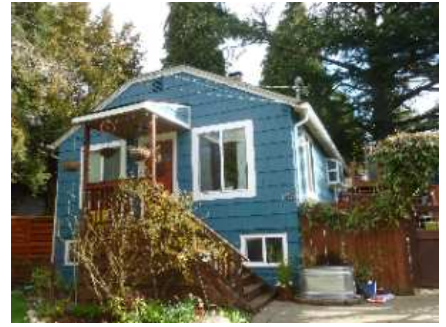
Evaluation Required - Immediately: trim at the soffit of the porch roof shows signs of water damage/penetration, I recommend hiring a licensed professional to further evaluate the issue and get a better idea of what we are working with or at the least to repair the compromised water penetrations

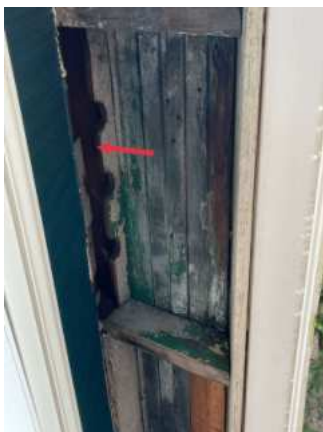
Mold and early stages of rot present on soffit.

Image 1.7.1 Soffit vents missing open exposure to attic. Broken bird blocking.

Repair or Replace - Immediately: Mold growth on soffits is generally black or dark grey and has a splotchy, semi-circular, and irregular appearance. Gone untreated, mold growth on exterior components can lead to accelerated deterioration over time. In the worst-case scenarios, it can deteriorate the roof framing and sheathing, leading to costly repairs. Additionally, the mold will likely continue to grow, which is aesthetically unpleasing.

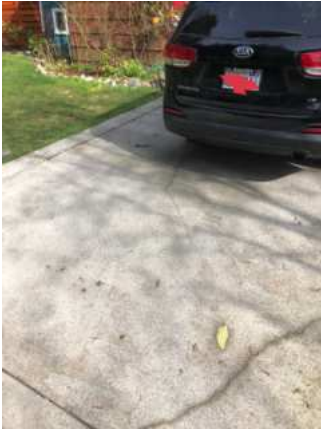
Monitor Driveway cracks present.

Image 1.8.1 Cracking in driveway

Monitor and consider repairing cracks to prevent further costly damage.

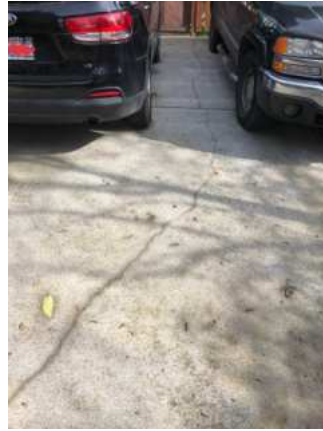
Image 1.8.2 Crack runs down the entire driveway

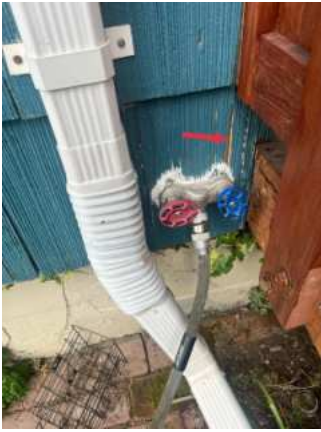
Cracked siding above spigot

Image 1.10.1 Cracked siding above hose spigot.

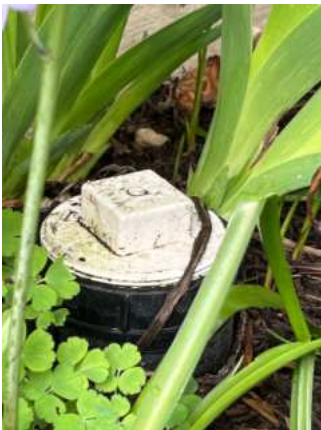
Image 1.11.1 Drain clean out located along the south wall of the house.

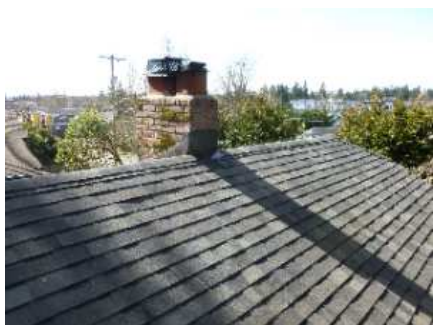
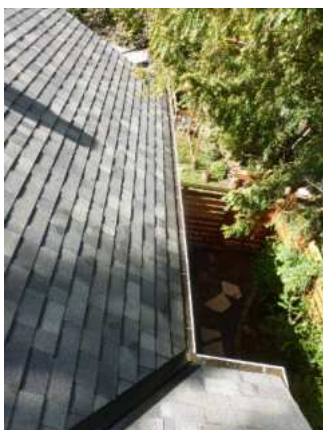
2.1 Roof Inspection Method	Description Condition	
Roofing		<ul style="list-style-type: none"> • Walked Roof • Overall condition is good. Shingles appear to be recently replaced.

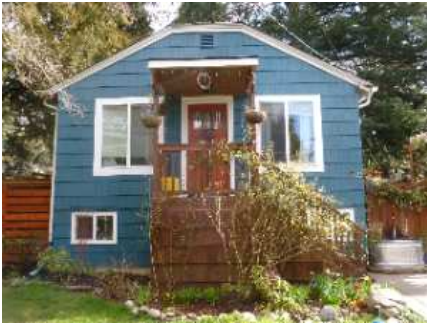
Image 2.2.1

2.2 Roof Type	Description	
Roofing		<ul style="list-style-type: none"> • jerkin head roof
	Condition	<ul style="list-style-type: none"> • new roof

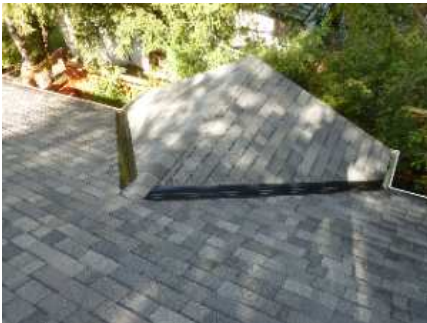
Image 2.3.1

| Description | • 3 Tab Shingle |
| Condition | • new |

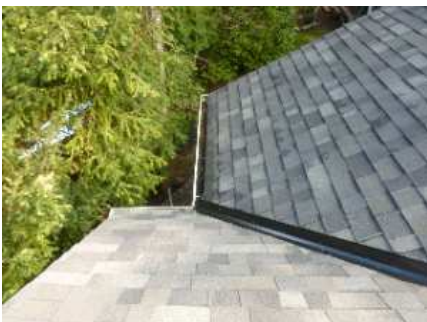
Flashing in good condition

Image 2.4.1 Recent flashing replacement

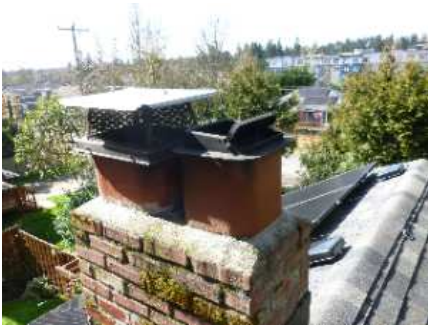
Image 2.5.1 Chimney cap present

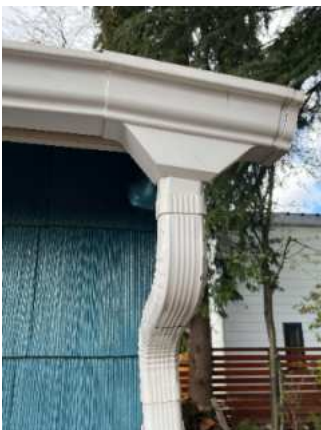
Repair or Replace Sagging in some portions of the gutter system.

Tree limbs overhanging gutters and roof.

Improper gutter sloping can lead to pooled water and potential structural damage.

Image 2.6.1 Gutter at downspout with noticeable sagging.

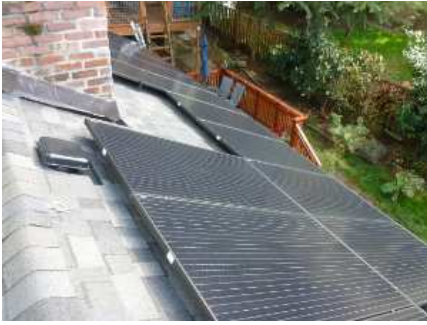
South portion of roof covered in solar panels. Unable to inspect below

Image 2.L.1 South facing roof with solar panels

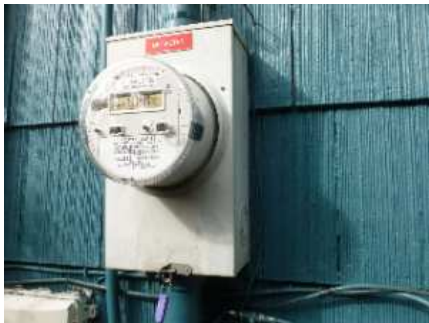
Image 3.1.1

Description	• Copper	Location	• Exterior • West Side • By Meter
--------------------	----------	-----------------	---

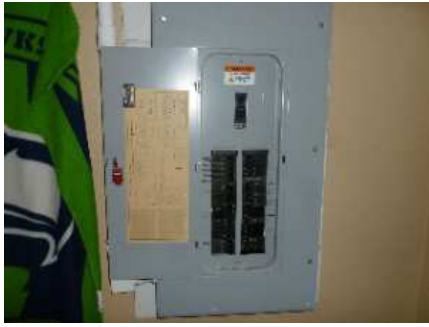
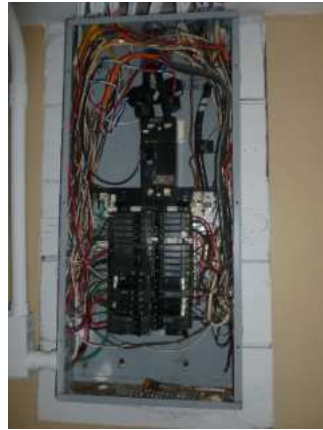
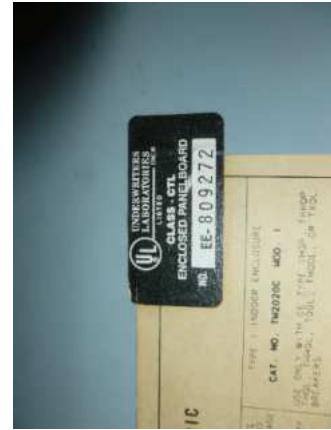
Description	• Breakers	Location	• West Side • Basement
--------------------	------------	-----------------	---------------------------

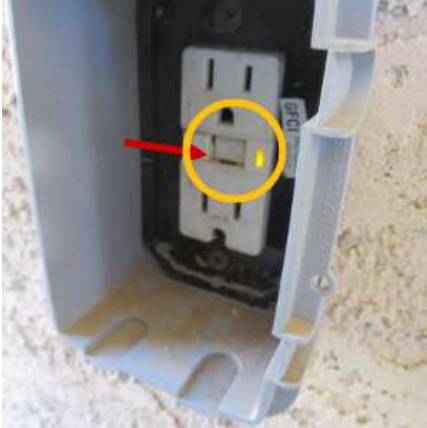
Image 3.6.1 Broken GFCI Test Button

Repair or Replace - Immediately: The test button on the GFCI is broken and should be repaired or replaced immediately.

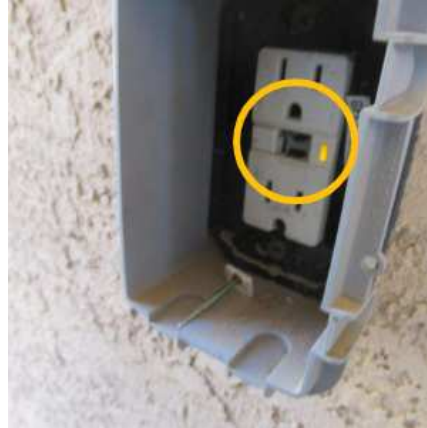
Image 3.6.2 Broken GFCI Test Button

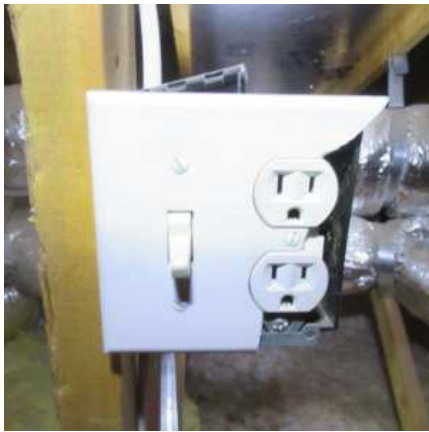
Description	• Switch/Outlet Combo Junction	Location	• Attic
Condition	• Damaged	Risk	• Electrocutation Hazard

Image 3.8.1 Broken Outlet Cover

Repair or Replace

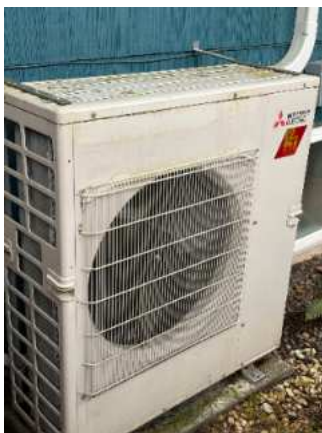
4.2 Heating Systems HVAC	Description	Location
	<ul style="list-style-type: none"> Split system ductless heat pump 	<ul style="list-style-type: none"> North wall Outside
	<ul style="list-style-type: none"> New 	
Make sure to have maintained once a year and to check for dust buildup, mold and rust.

Image 4.2.1 Condenser unit located on North facing wall

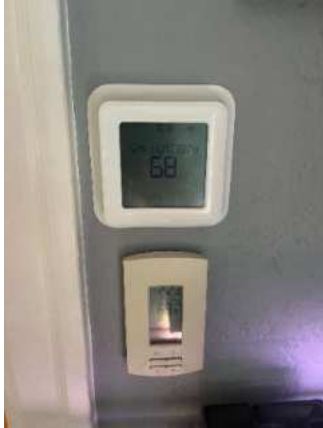
Image 4.3.1

Description • Digital **Location** • Hallway
 • Basement

Condition • New unit

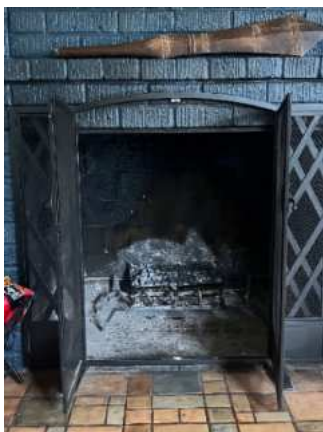
Image 4.4.1

Description • Masonry **Location** • Living Room
Condition • Dirty **Risk** • Fire Hazard

Upgrade - Increase Performance: cleaning the chimney at least once a year is recommended to prevent un-burnt residue build up on the internal surfaces which can catch fire and cause your house to catch fire (as most fireplaces are connected to the timber framework of the house for stability).

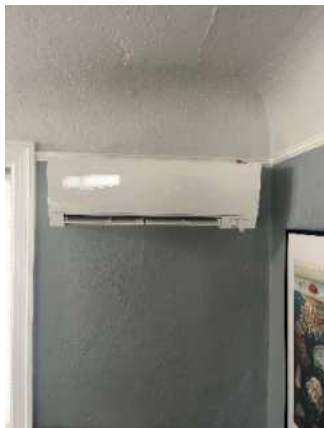
Filters in need of cleaning

Image 4.5.1 Evaporator unit in living room

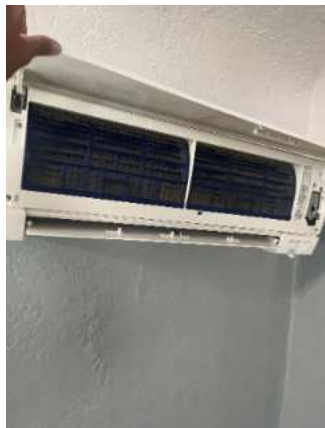
Image 4.5.2 Filters need cleaning

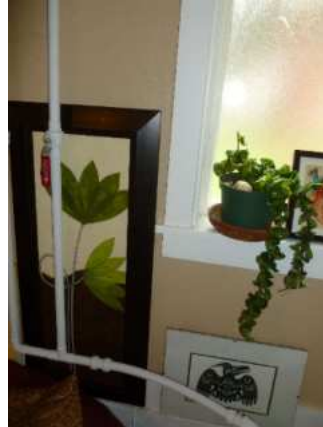
Image 5.2.2

5.2 Water Supply Piping	Description	Location
Plumbing	<ul style="list-style-type: none"> Galvanized Steel PolyButylene 	<ul style="list-style-type: none"> Underground Supply
	Condition <ul style="list-style-type: none"> PolyButylene past life expectancy 	Risk <ul style="list-style-type: none"> Water Damage leaks

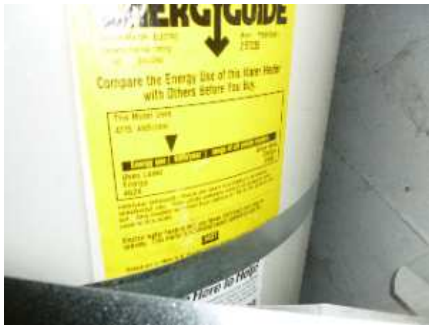
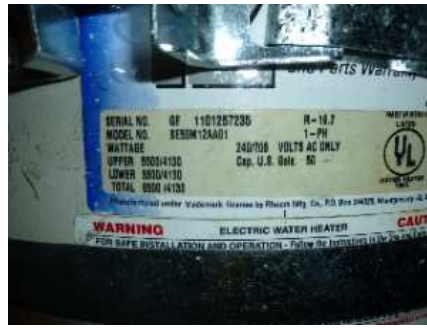
Water heater is past life expectancy.

Repair or Replace - Immediately: The tank to your water heater should be flushed on an annual basis. Doing so drains the sediment from the tank, which is then able to work more efficiently. With a yearly tank flush, a water heater is likelier to last for its full life expectancy of roughly ten years.

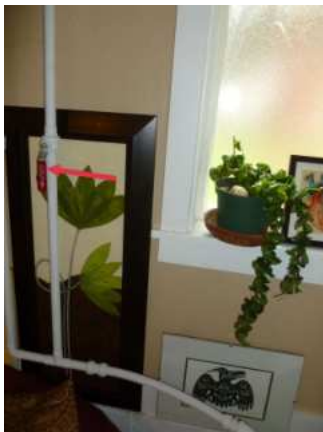
Image 5.5.1 Shut off ball valve

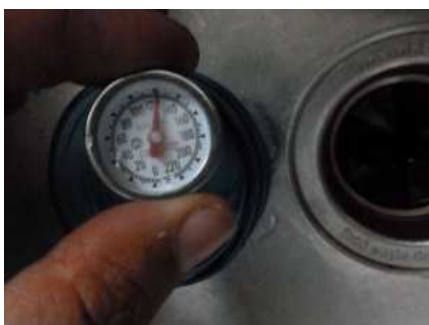
Image 5.6.1 Water temperature at 120 degrees

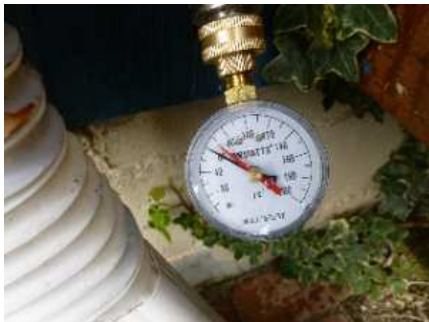
Image 5.8.1

Description • 70 psi

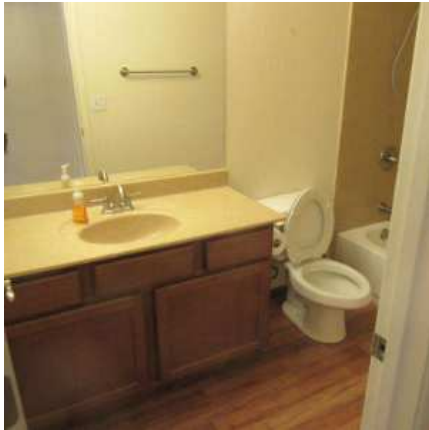
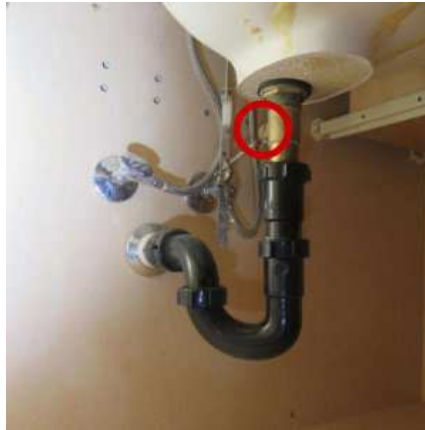
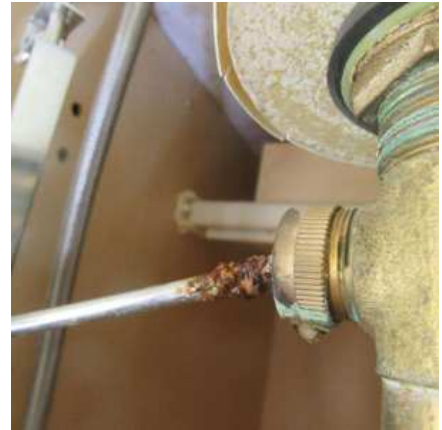
Repair or Replace - Immediately: A leak is present at the stopper rod/drain connection. The mechanism can be dismantled to check seals for wear or cracks.

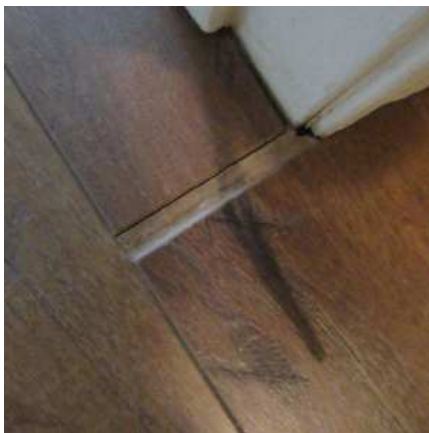
Image 6.1.1 Hardwood Flooring Gap - Master Bdrm Entry

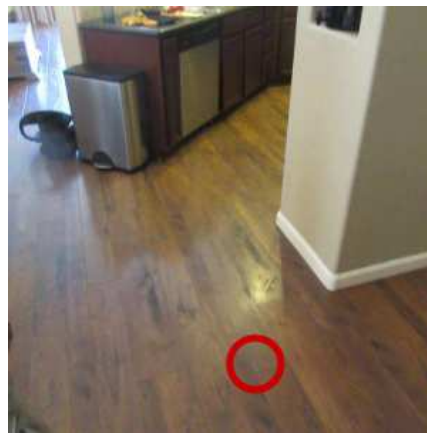
Monitor The corner of a hardwood flooring piece in the kitchen is delaminating and may get worse over time. Please monitor it at your discretion.

Image 6.1.2 Delamination spot in kitchen

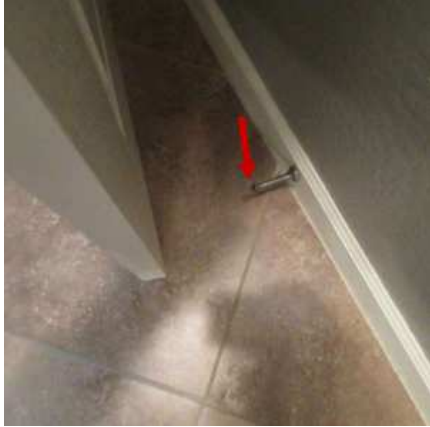
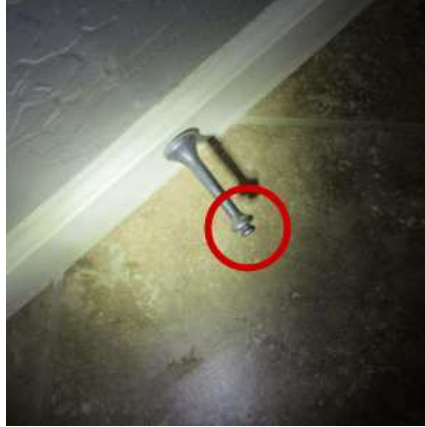
Repair or Replace Two of the door stops are missing the rubber bumpers that absorb the impact without denting the door. These can be purchased at your local hardware store and installed easily.

Image 6.2.1 Bedroom 1

Image 6.2.2 Bedroom 2

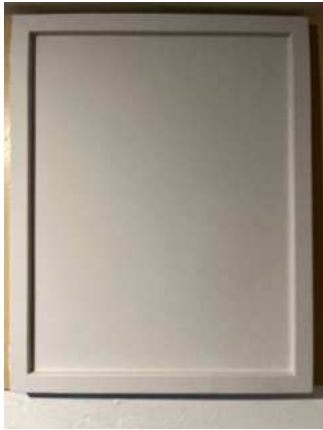
Crawl space entry is not insulated or lockable. Consider replacing for secure entry.

Image 7.1.1 Crawl space entry door, not insulated.

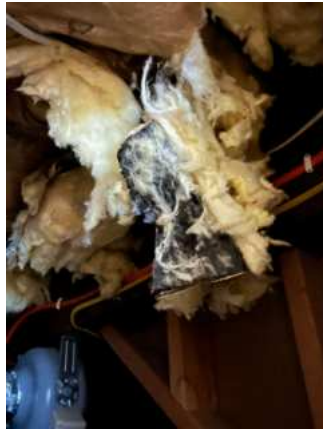
Image 7.1.2 Example of falling insulation in crawl space.

Evaluation Required - Immediately: Suggest having a professional exterminator evaluate the crawl space. Replace damaged insulation and vapor barrier.

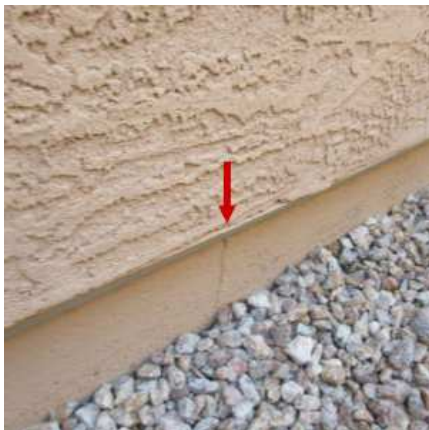
Image 7.2.1

There are typical settling cracks in the foundation walls that would not need a specialist evaluation.

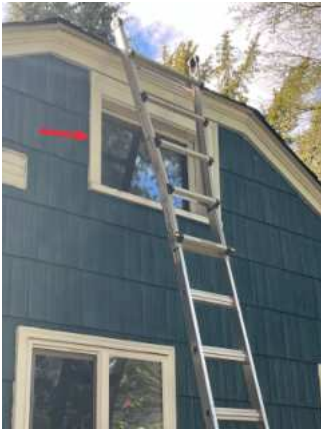
Description	• From Access	Location	• East facing wall
Condition	• One hinge on window attic access is broken.	Risk	• Structural Damage

Image 7.3.1 Attic access located outside on east facing wall.

Repair or Replace - Immediately: Attic access is outside. Currently access is hanging on one hinge. If remaining hinge fails access will be exposed to the elements causing water and rodent penetration.

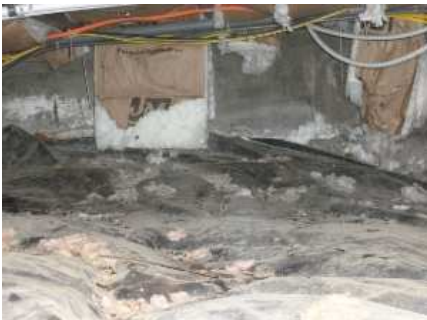
- Crawl Space Access was Limited

Image 7.L.1 Portion of crawlspace inaccessible because of noticeable rodent debris.

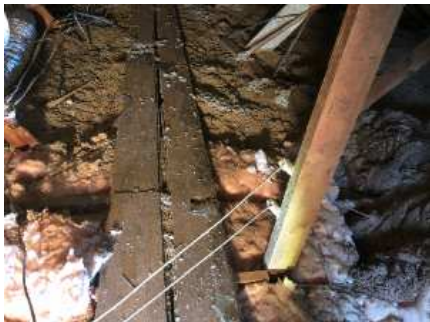
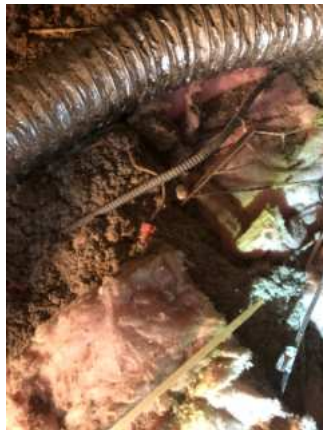
8.1 Roof / Attic Insulation Insulation & Ventilation	Description	<ul style="list-style-type: none"> • Cellulose • Glass Fiber 	Location	<ul style="list-style-type: none"> • Attic
	Combination of cellulose insulation and fiber glass

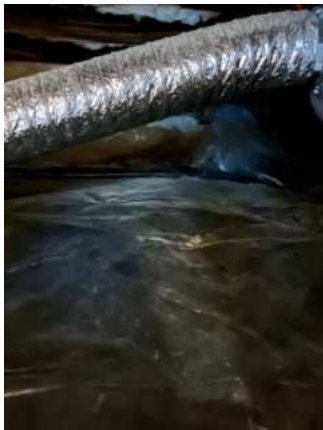
Monitor Some damage to vapor barriers. Possibly related to previous rodent infestation.

Image 8.3.1 Poly vapor barrier in crawl space
