CASE STUDY: WAGNER SMITH

# Intelligent inspections are here.

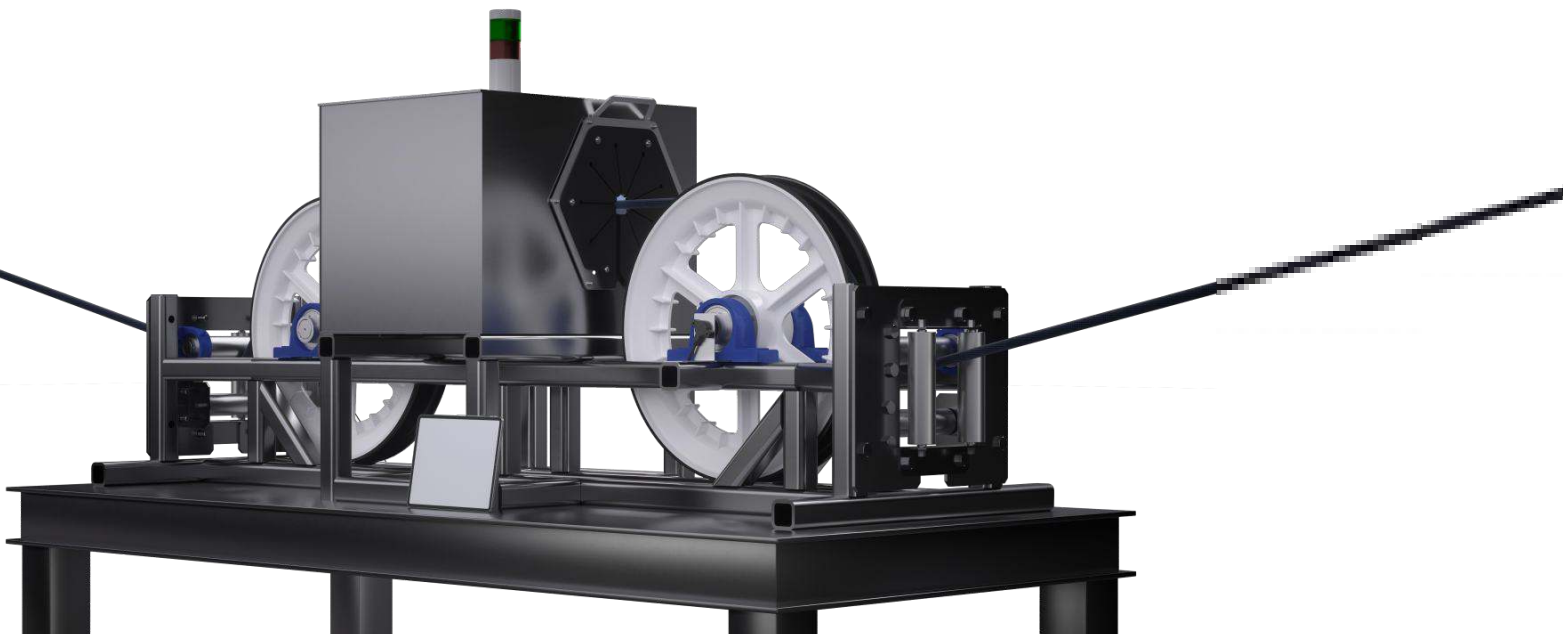
The Scope hardware is designed as a standalone inspection unit, specifically for placement between two stringing units as line is spooled from one machine to the other. The unit comes with a mounting table for operators to easily access tools and splice rope. Multiple cameras surround the rope subject, capturing 360° views of the line inside the device.

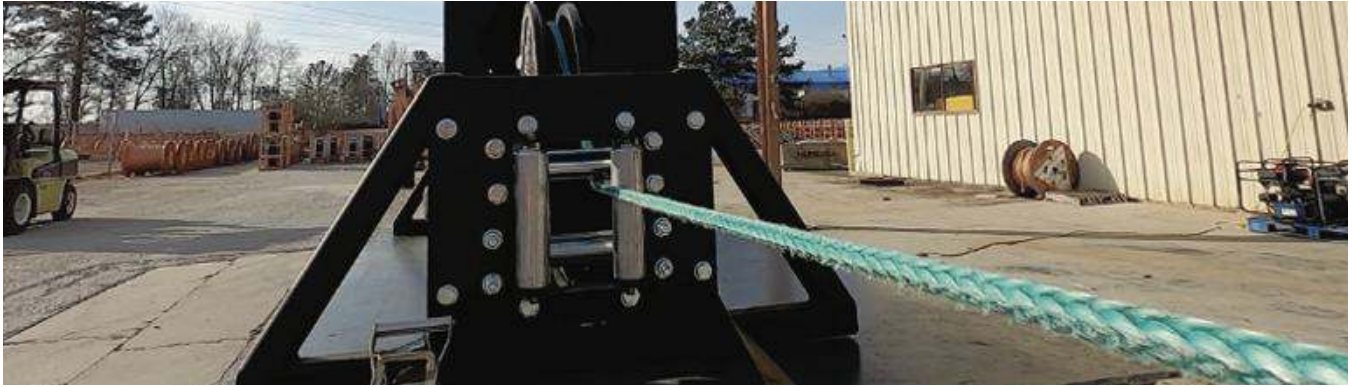
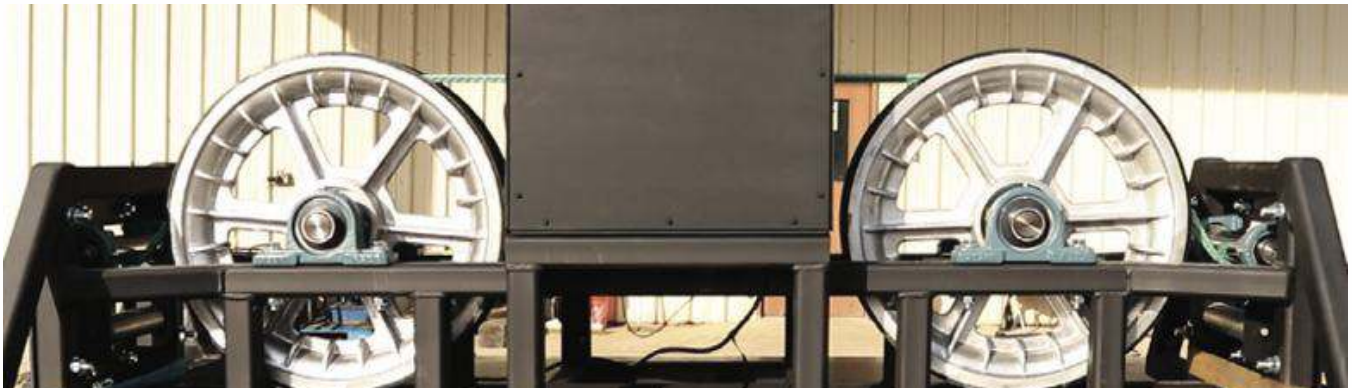
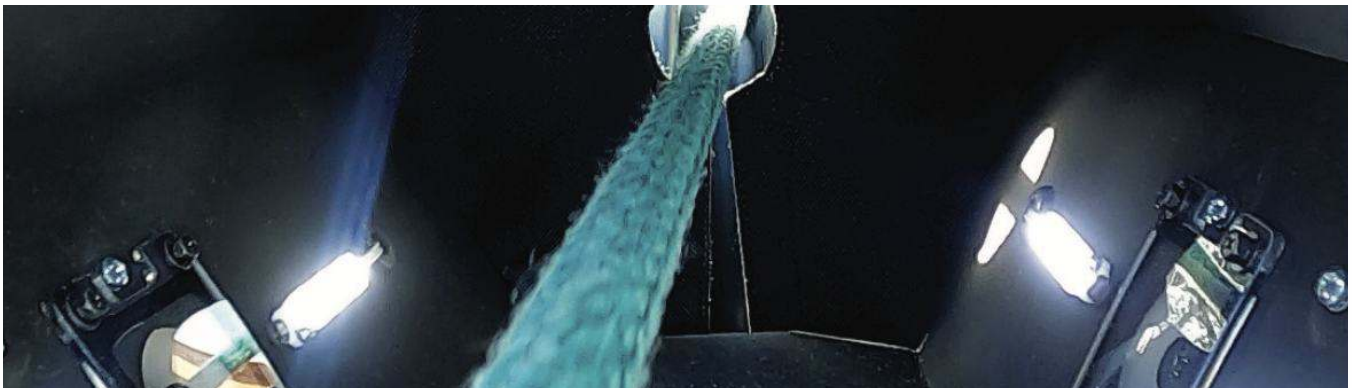
Abrasion

Cut Strands

Splices

Discoloration

Debris

The advanced technology in the Scope platform automatically captures and uploads image data of any detected damage or line anomaly, making it readily accessible online for review by both operators and fleet managers.
